Landslide Hazard Assessment

Proposed Residential Development

Old Montreal Road
Ottawa, Ontario

Report PG5201-2 Revision 5 dated December 20, 2024

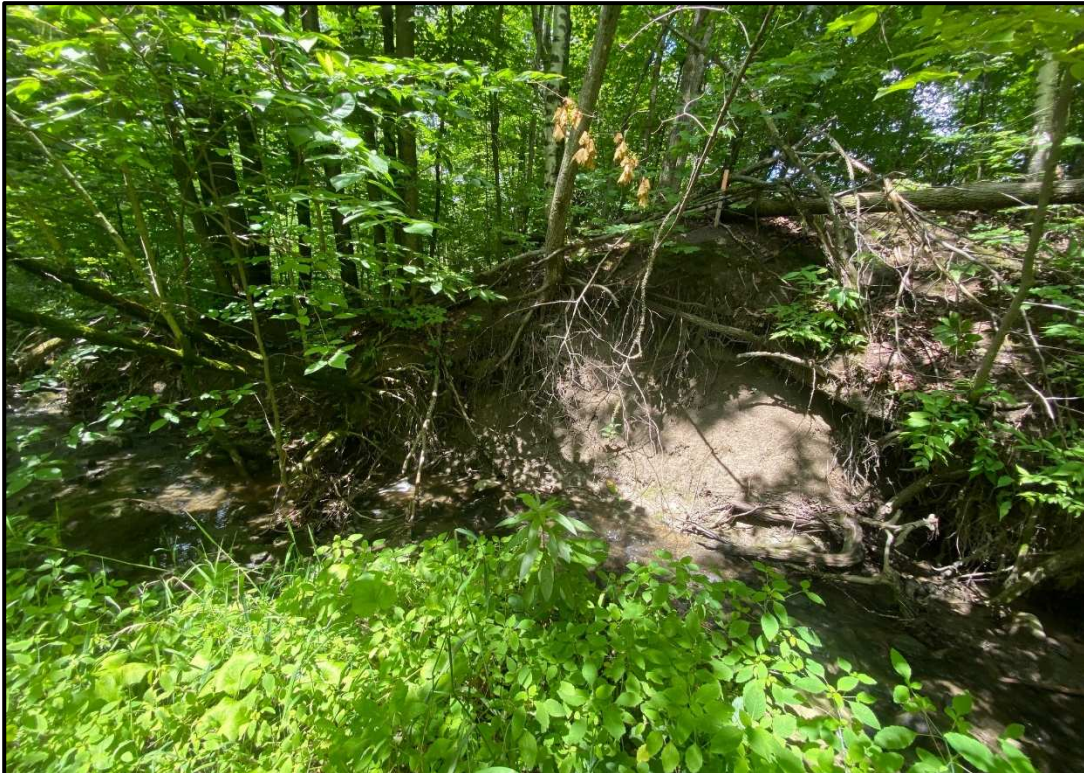
Photo 18B: Photo taken on July 19, 2023 of the north slope face, looking north at section GG.

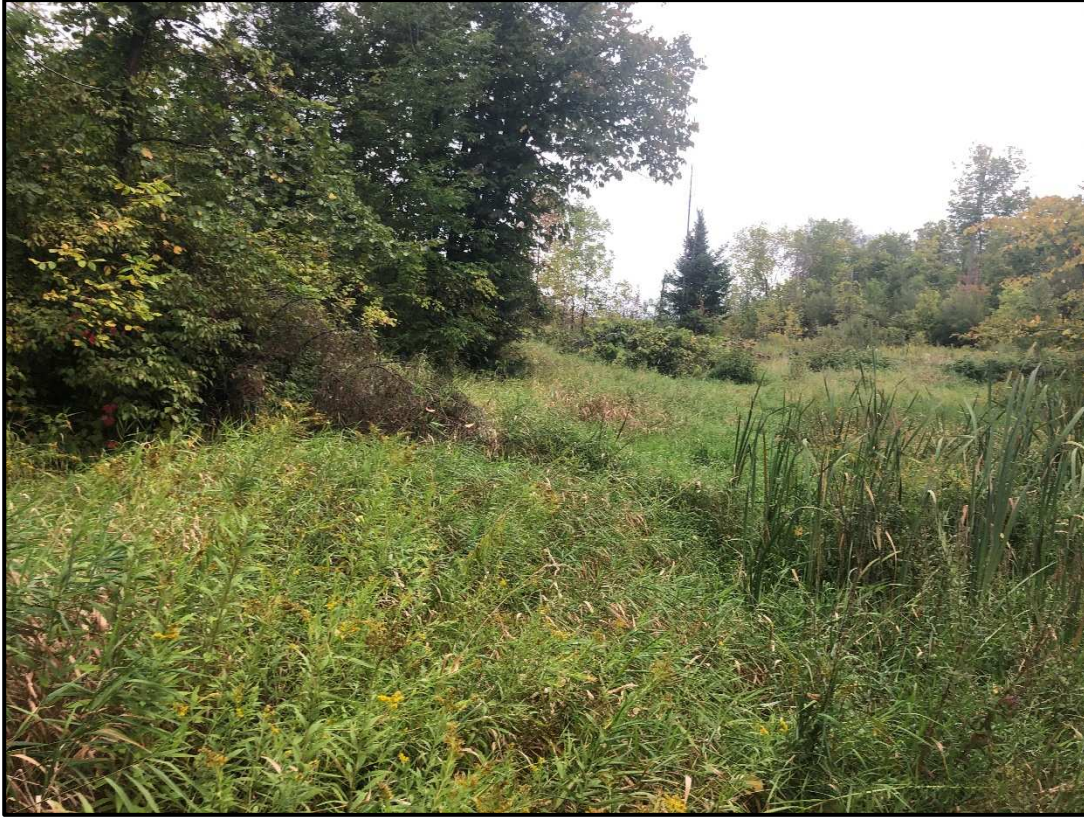
Photo 19A: Photo taken on September 10, 2020 along the watercourse, looking east (upstream).

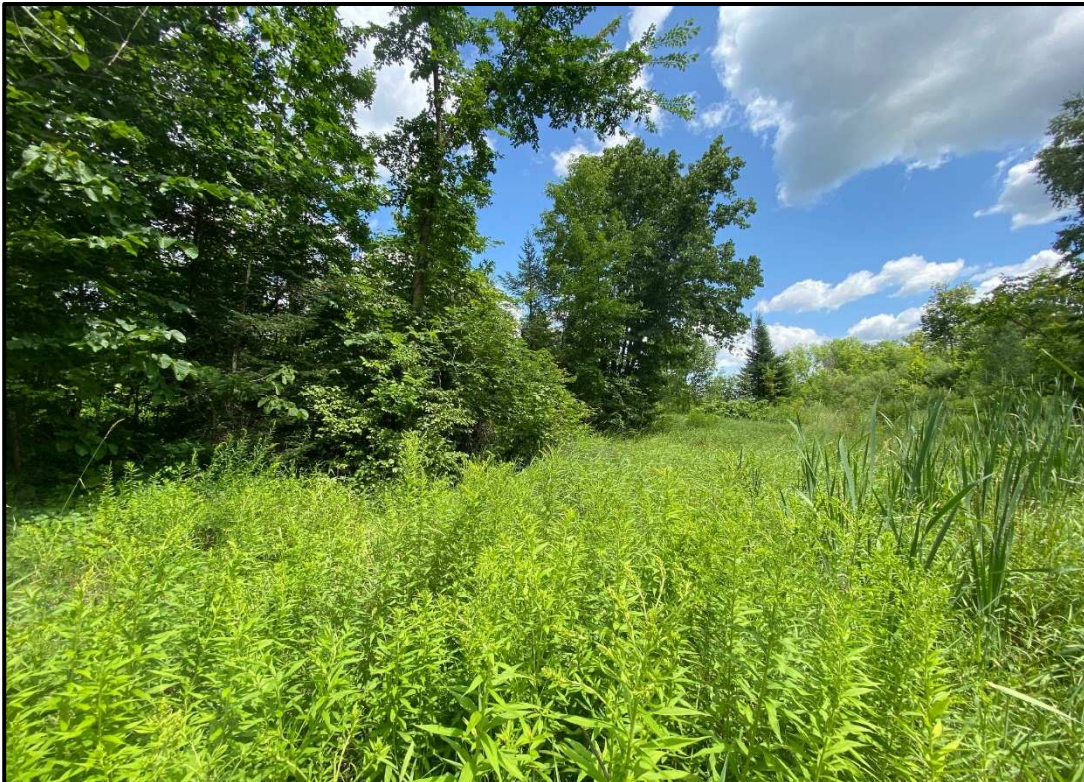
Photo 19B: Photo taken on July 19, 2023 along the watercourse, looking east (upstream).

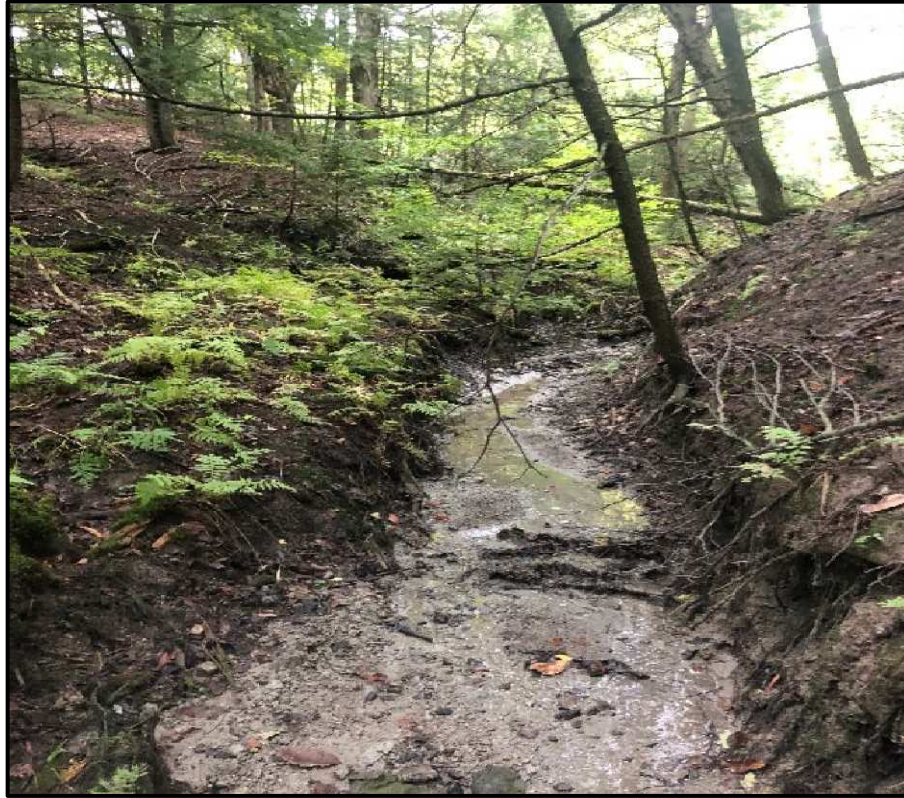
Photo 20A: Photo taken on September 10, 2020 along the watercourse along Mid-Branch 1 looking east (upstream) near Section OO.

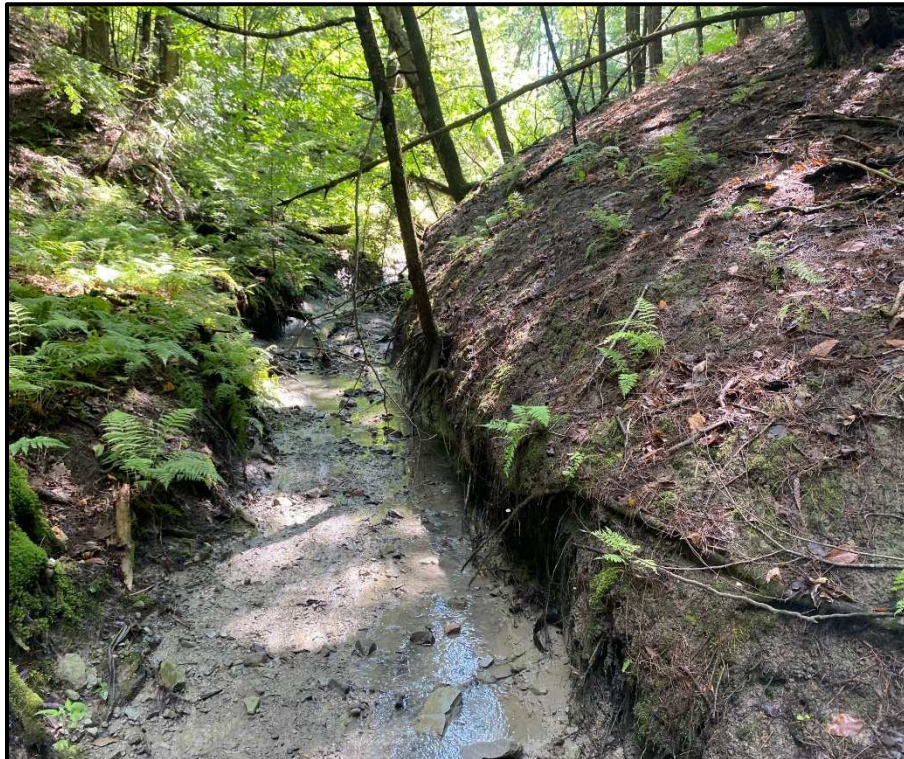
Photo 20B: Photo taken on July 19, 2023 along the watercourse along Mid-Branch 1 looking east (upstream) near Section OO.

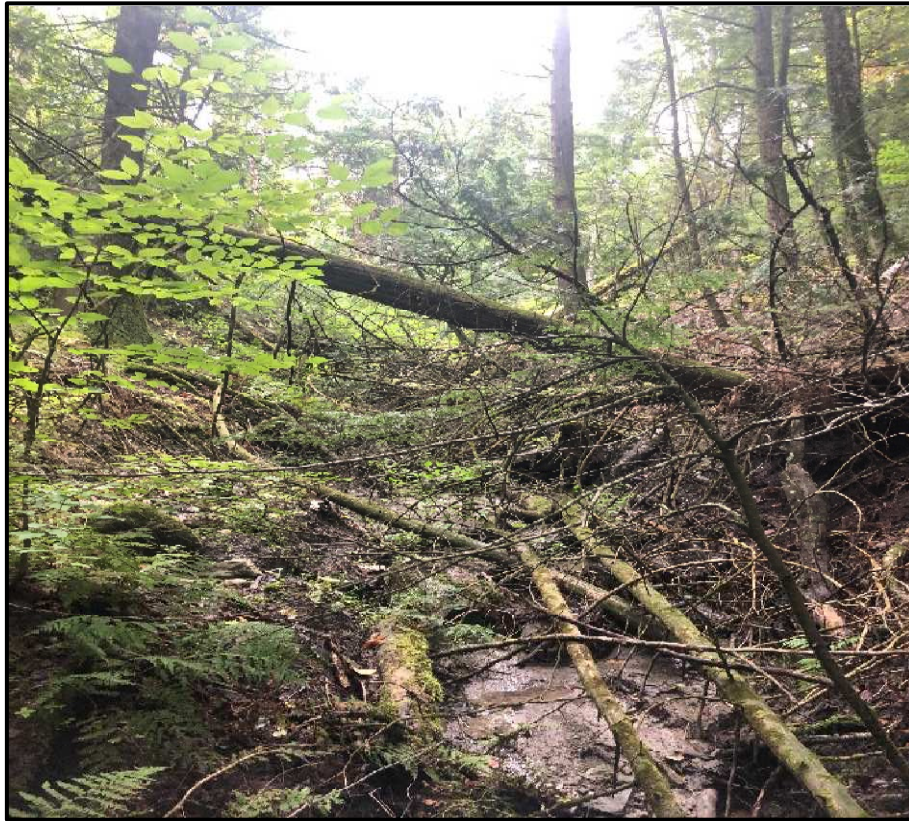
Photo 21A: Photo taken on September 10, 2020 along the watercourse along Mid-Branch 1 looking east (upstream) near Section N.

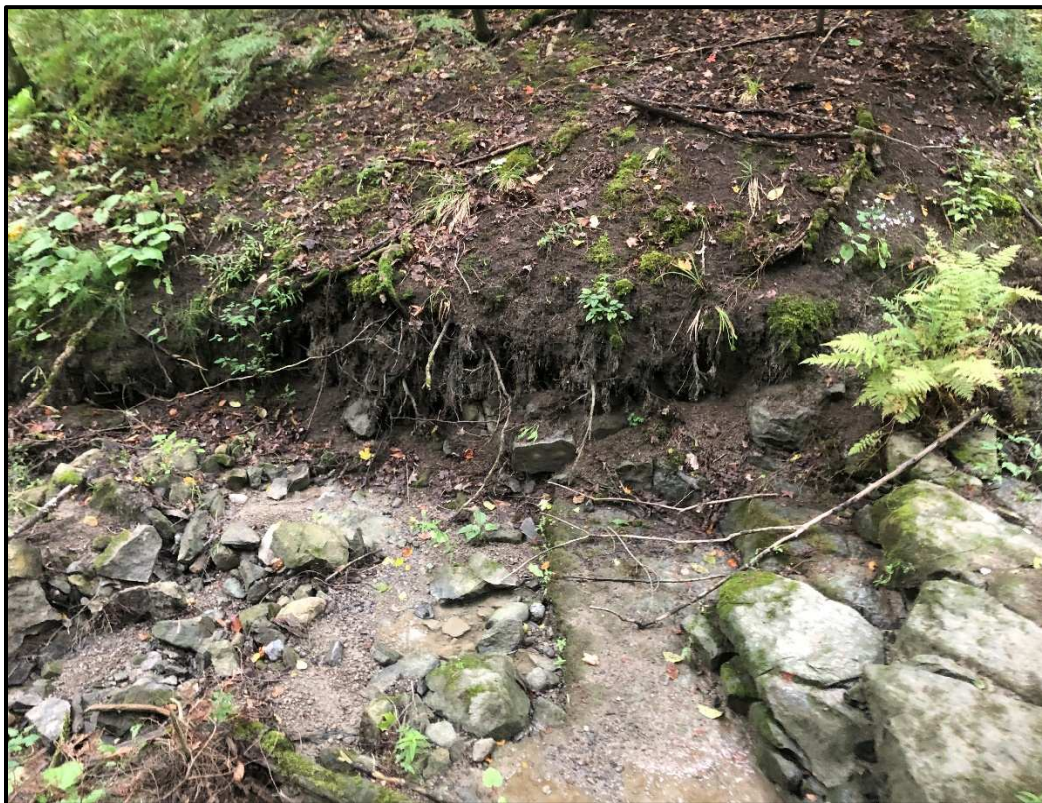
Photo 22A: Photo taken on September 10, 2020 along the watercourse along Mid-Branch 1 looking north.

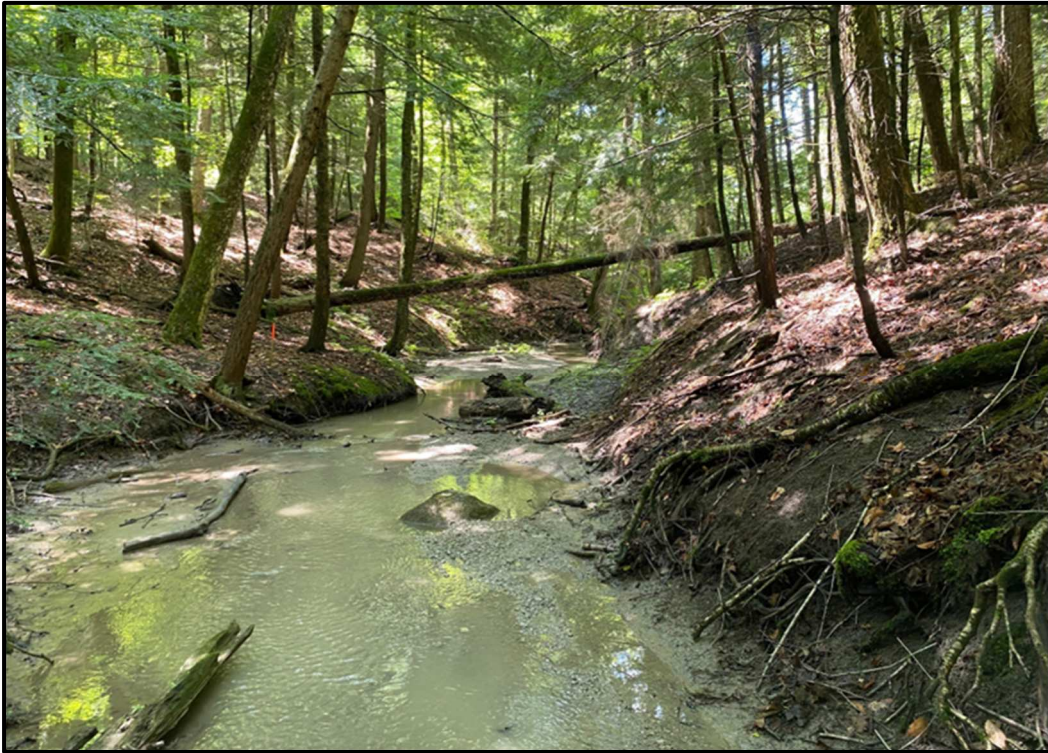
Photo 23: Photo taken on July 19, 2023 of the north slope face, looking west (downstream) near Section H.

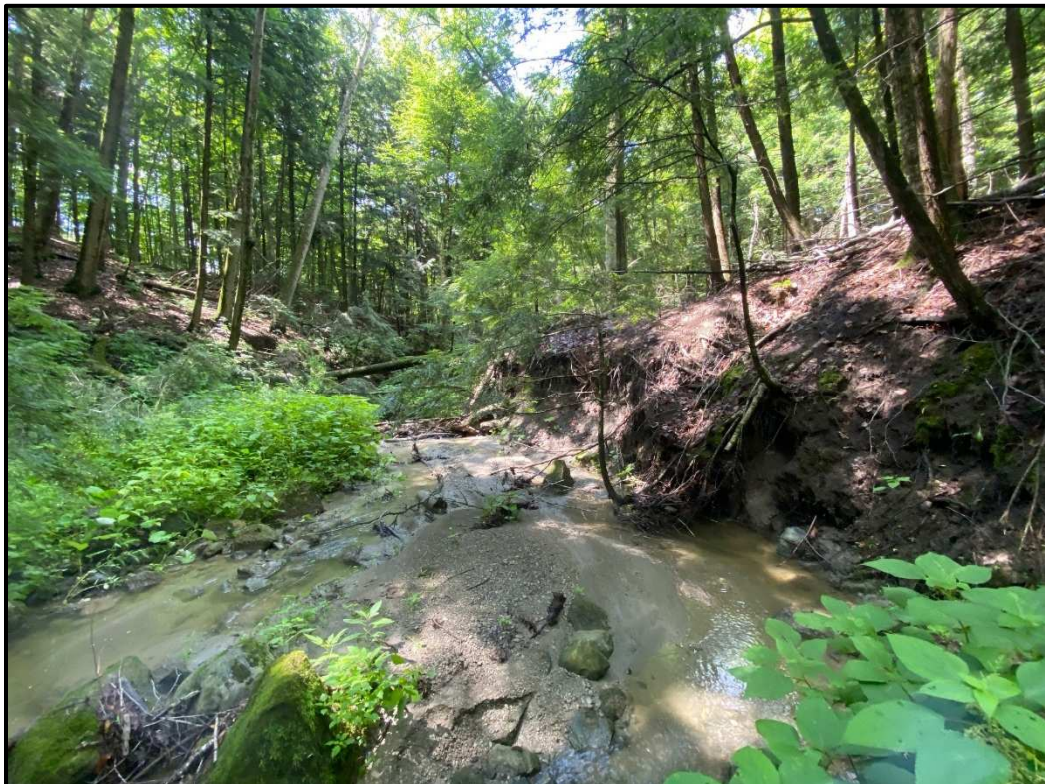
Photo 24: Photo taken on July 19, 2023 of the north slope face, looking west (downstream) near Section CC.

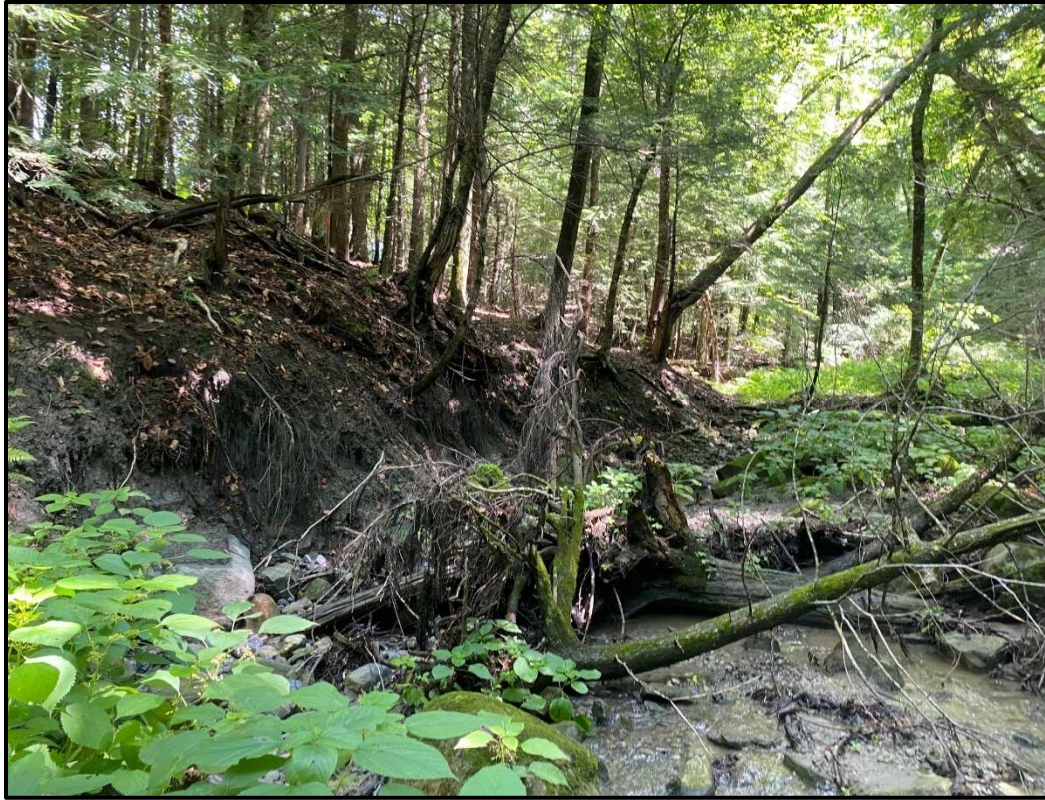
Photo 25: Photo taken on July 19, 2023 of the north slope face, looking east (upstream) near Section CC.
