June 3rd, 2019

RE: Woodlot S-23 Large Tree Inventory – Minto Communities and Valecraft Homes Kanata North
Developments

APPENDIX A – TREE PHOTOS

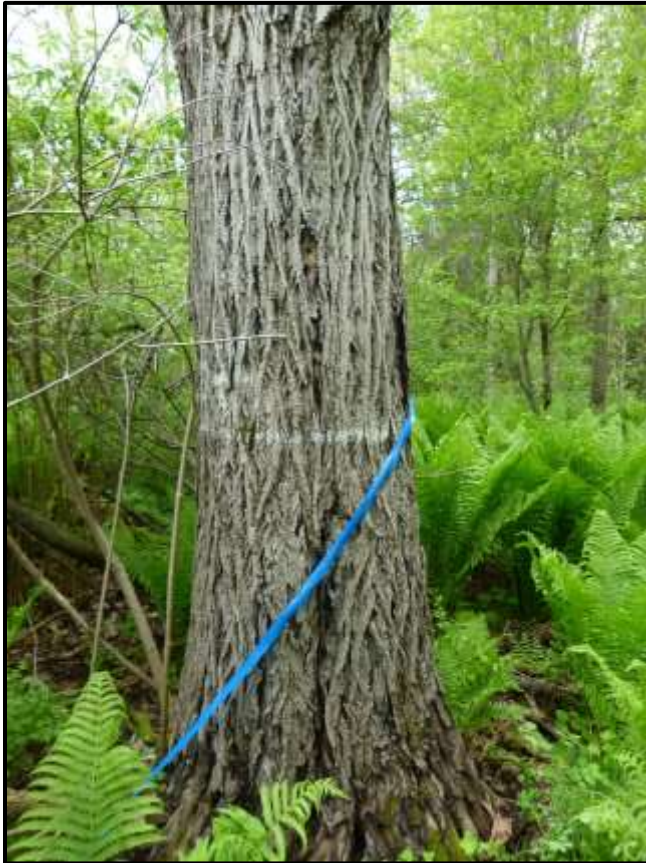
Photograph 6: Tree #7 – Category 1 Butternut (May 27th, 2019).

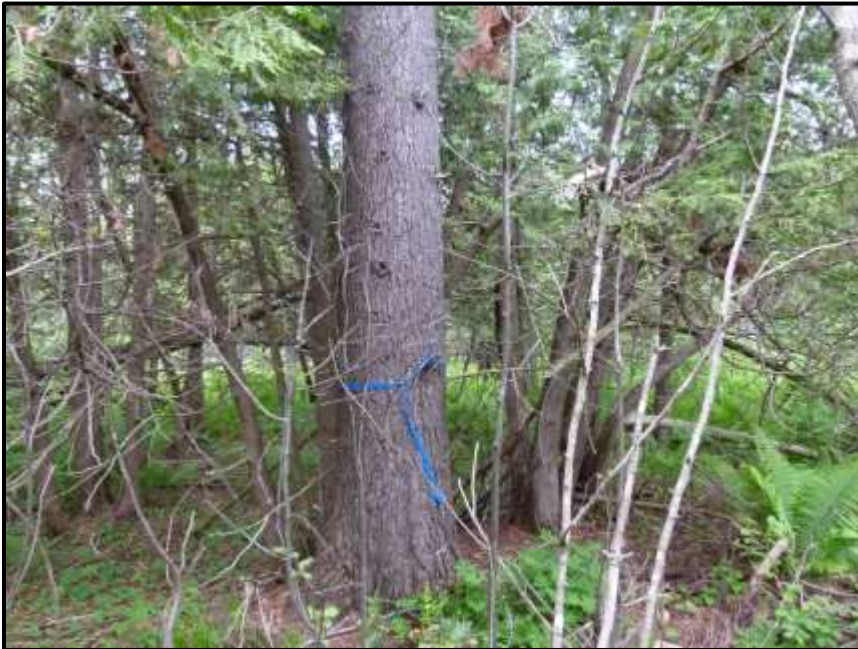
Photograph 8: Tree #9 – White Pine in good condition (May 27th, 2019).

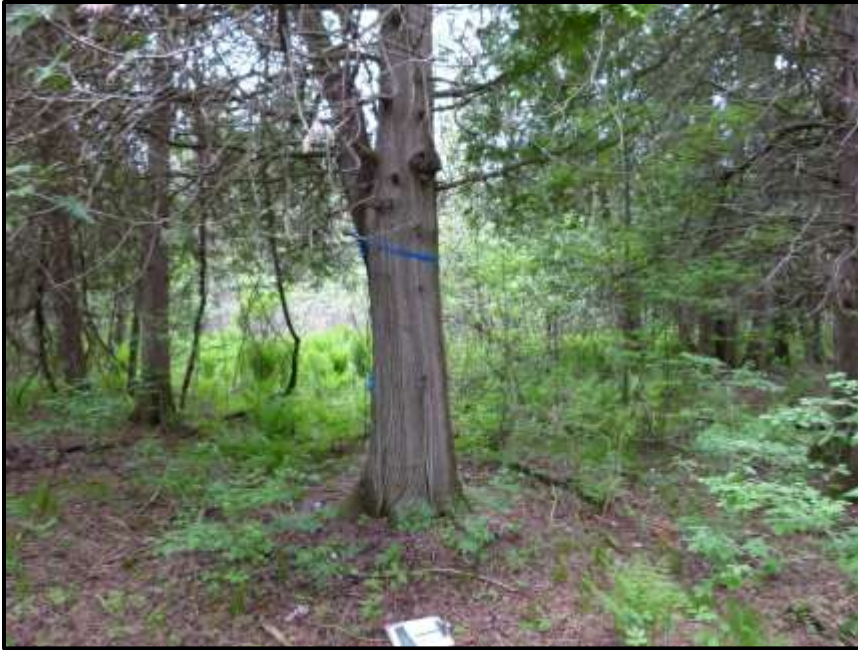
Photograph 9: Tree #10 – White Cedar in good condition (May 27th, 2019).

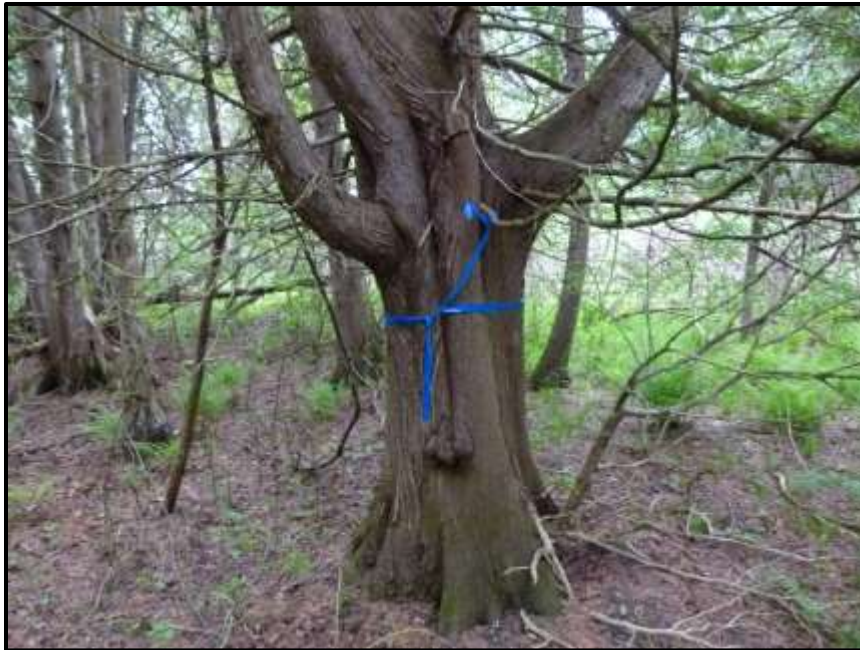
Photograph 11: Tree #12 – White Cedar in good condition (May 27th, 2019).

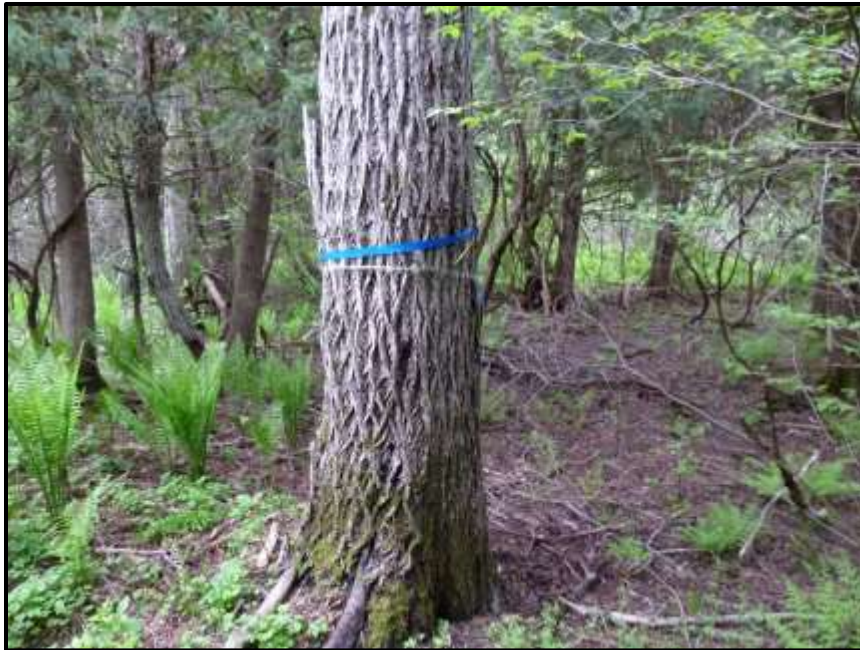
Photograph 13: Tree #14 - Category 3 Butternut (May 27th, 2019).

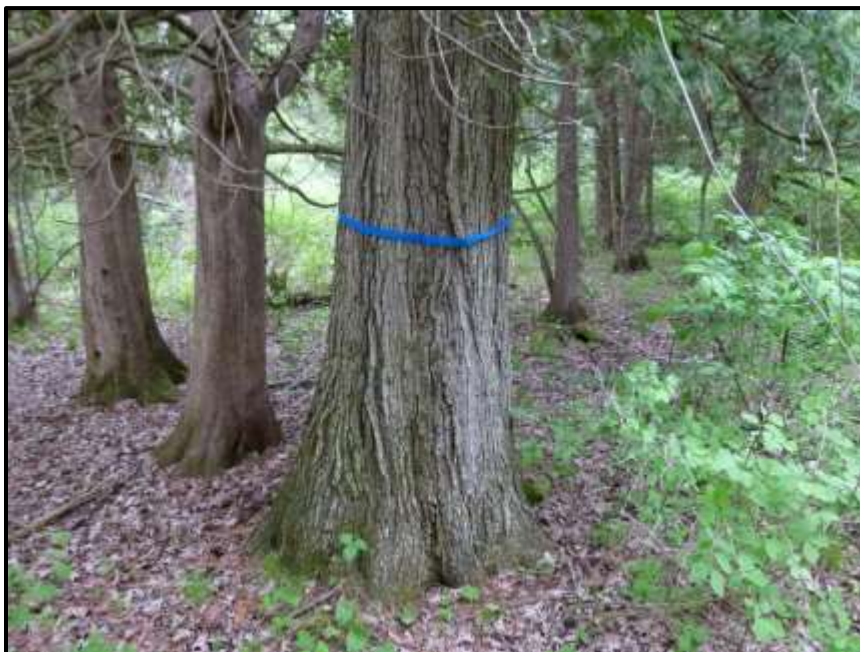
Photograph 14: Tree #15 - Bur Oak in good condition (May 27th, 2019).

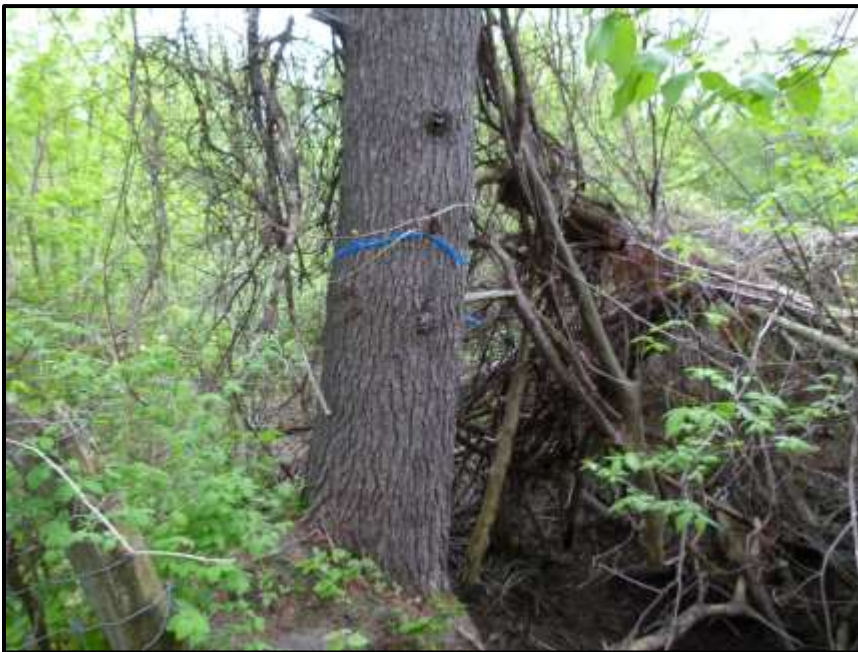
Photograph 16: Tree #17 - White Pine in good condition (May 27th, 2019).

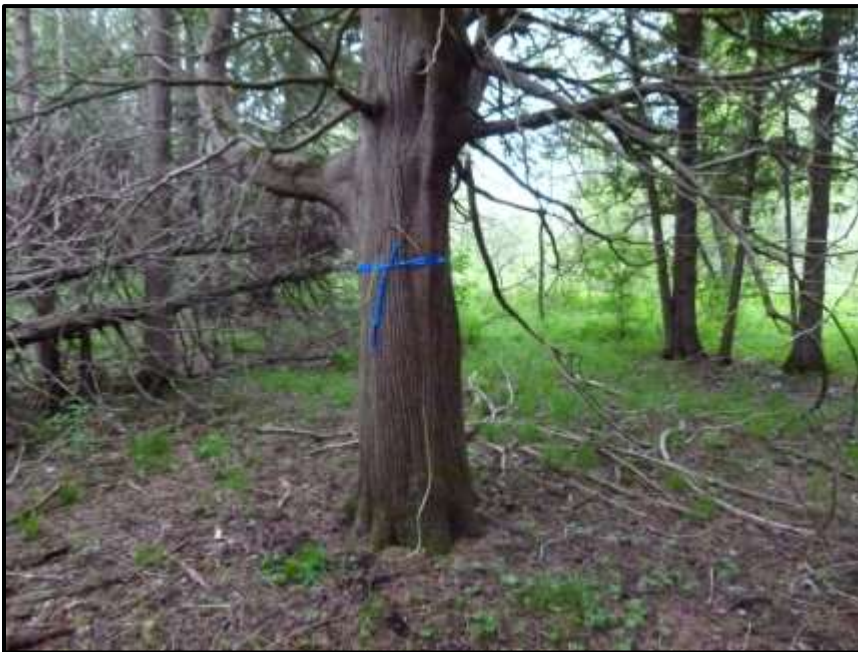
Photograph 18: Tree #19 – White Cedar in good condition (May 27th, 2019).

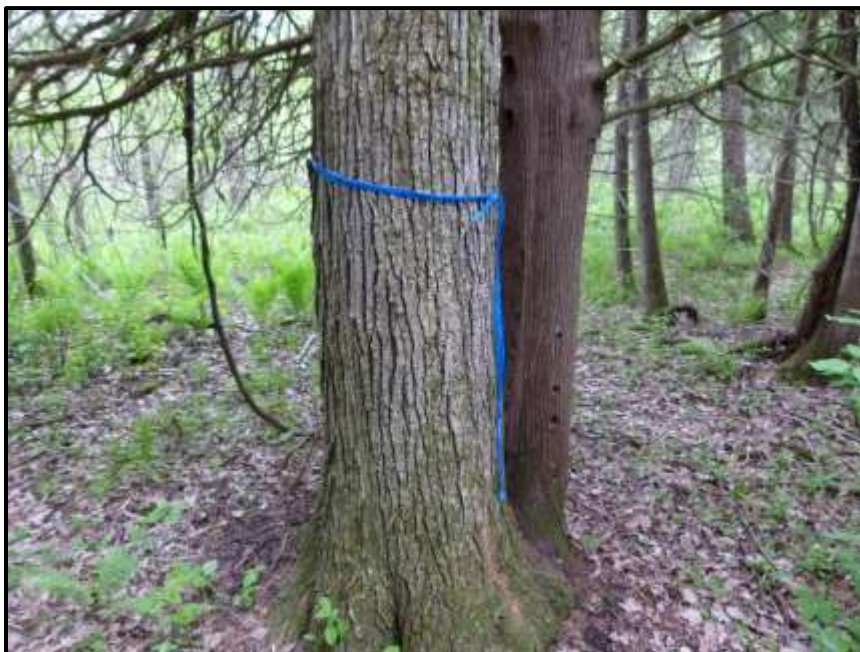
Photograph 20: Tree #21 – Bur Oak in good condition (May 27th, 2019).

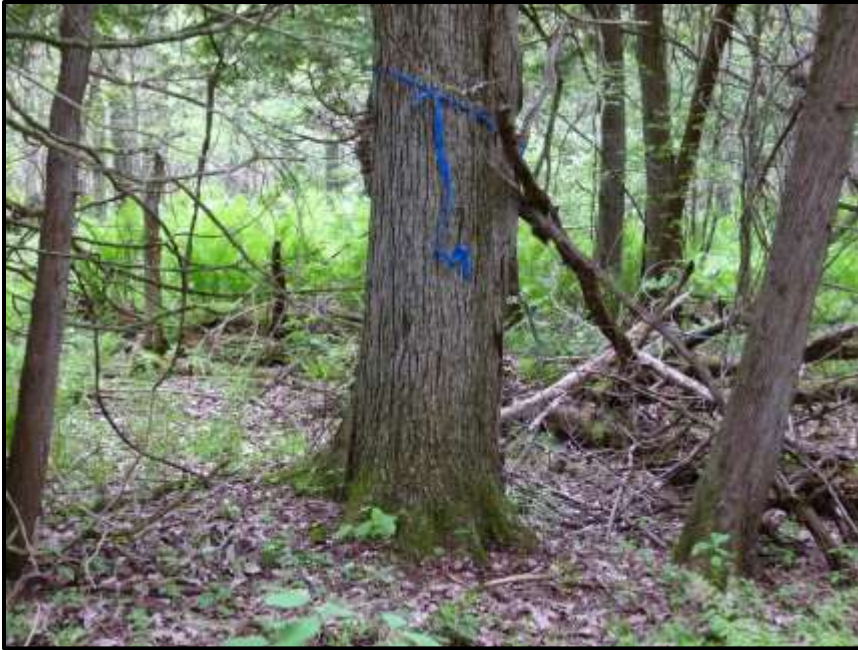
Photograph 21: Tree #22 – Bur Oak in good condition (May 27th, 2019).

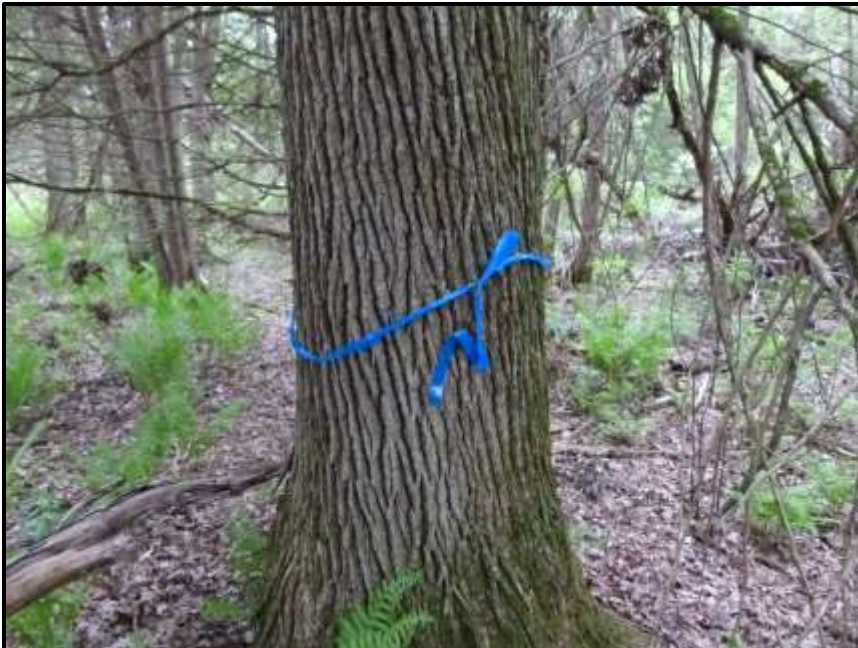
Photograph 22: Tree #23 – Bur Oak in good condition (May 27th, 2019).

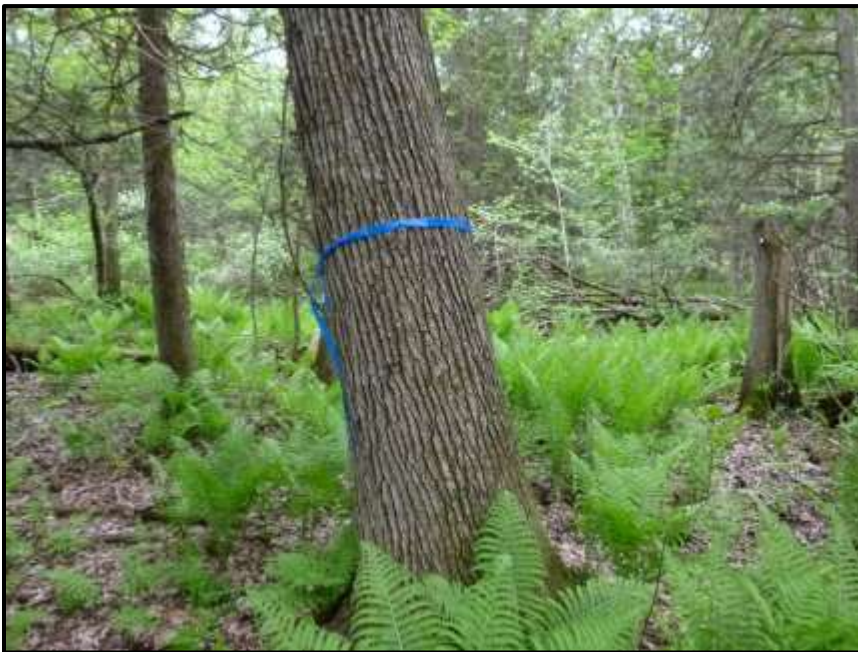
Photograph 26: Tree #27 – Bur Oak in good condition (May 27th, 2019).

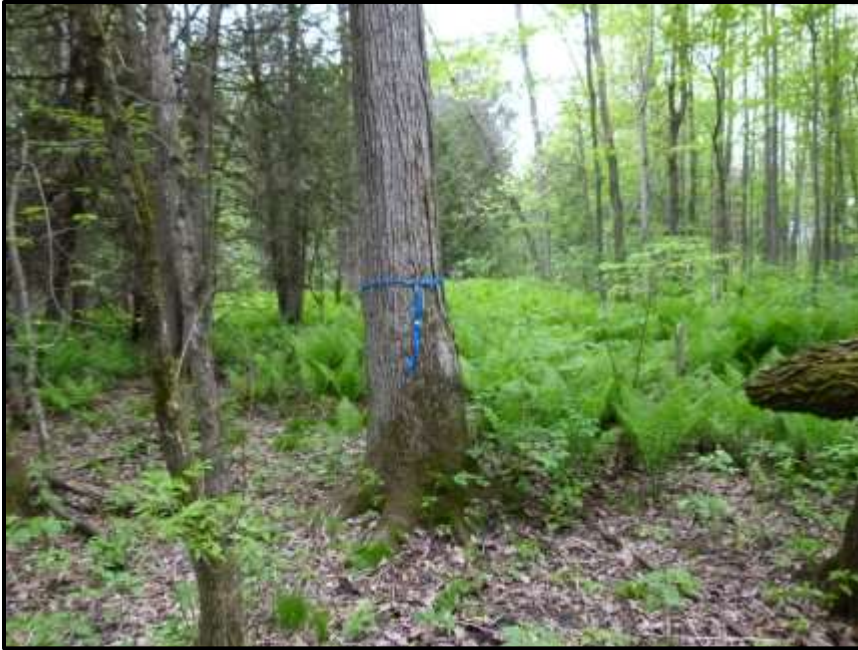
Photograph 27: Tree #28 – Bur Oak in good condition (May 27th, 2019).

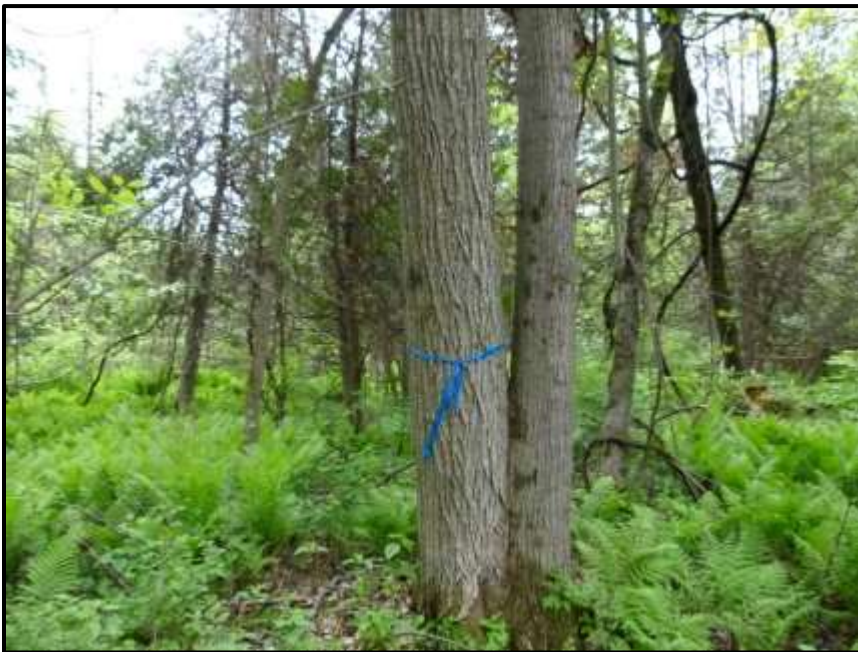
Photograph 28: Tree #29 – Bur Oak in good condition (May 27th, 2019).

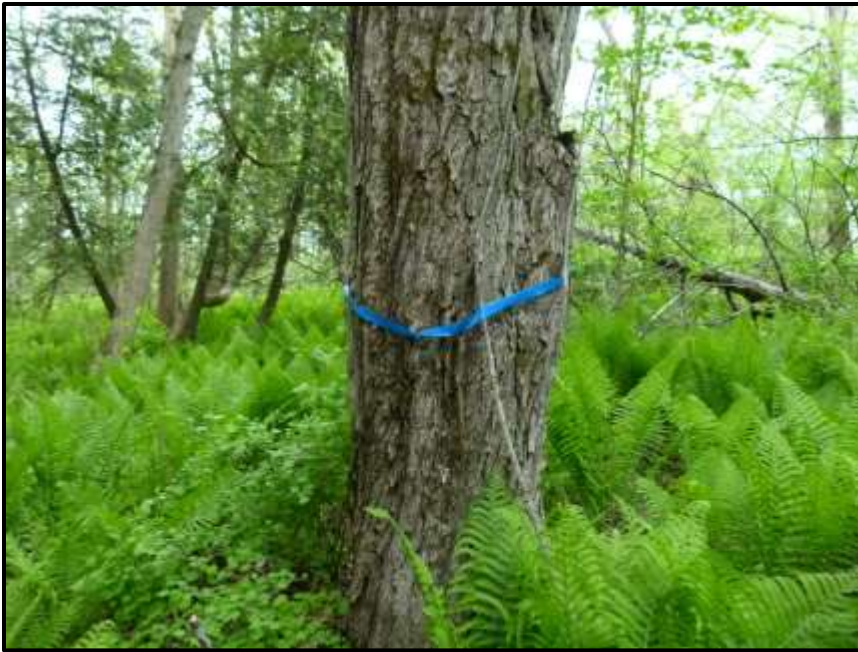
Photograph 29: Tree #30 – Sugar Maple in good condition (May 27th, 2019).

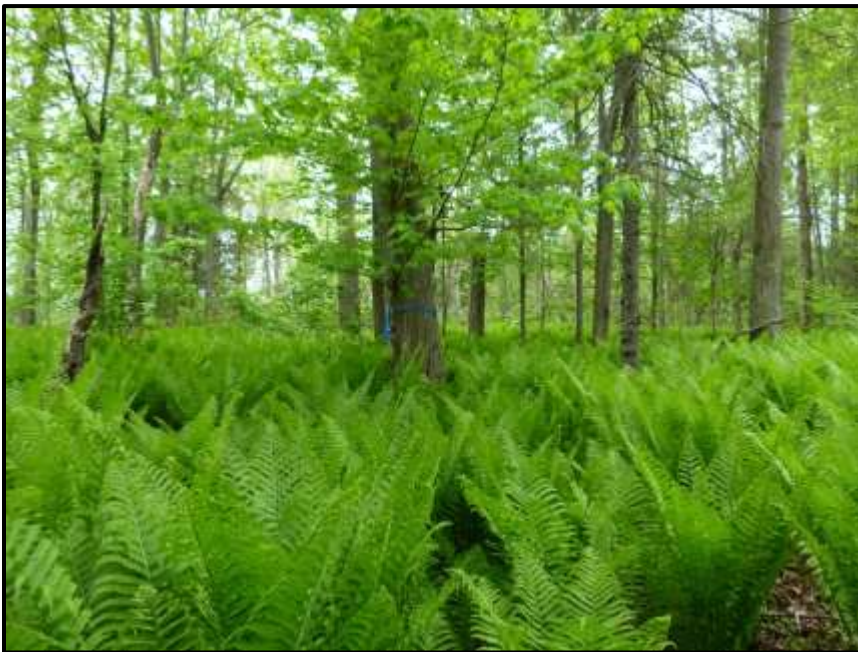
Photograph 30: Tree #31 – Sugar Maple in good condition (May 27th, 2019).

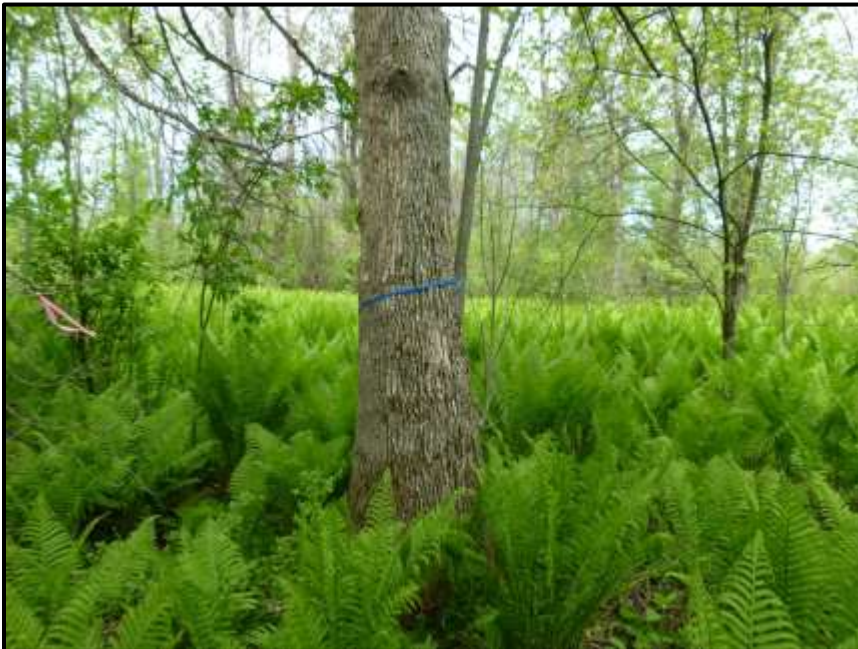
Photograph 32: Tree #33 – dead White Ash (May 27th, 2019).

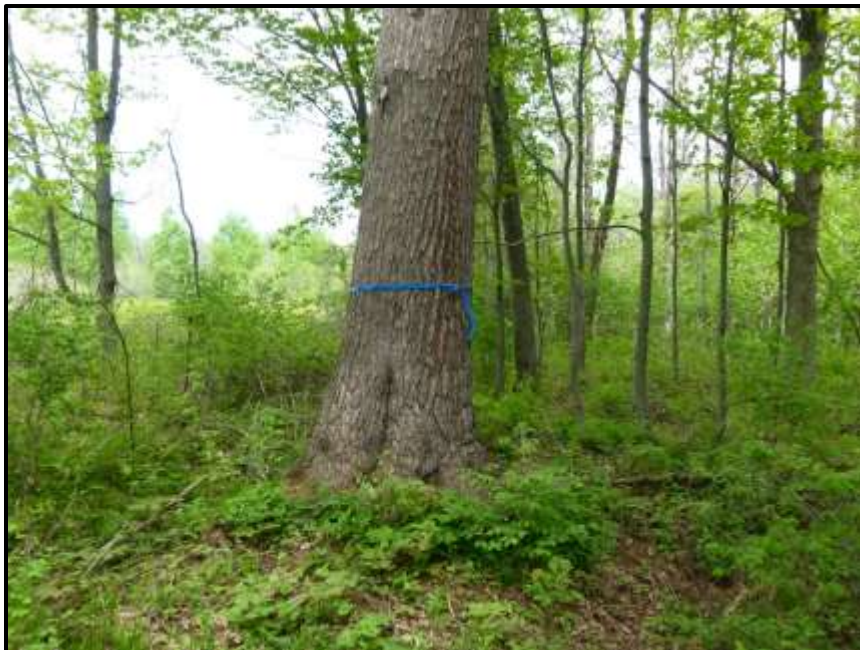
Photograph 34: Tree #35 – White Pine in good condition (May 27th, 2019).

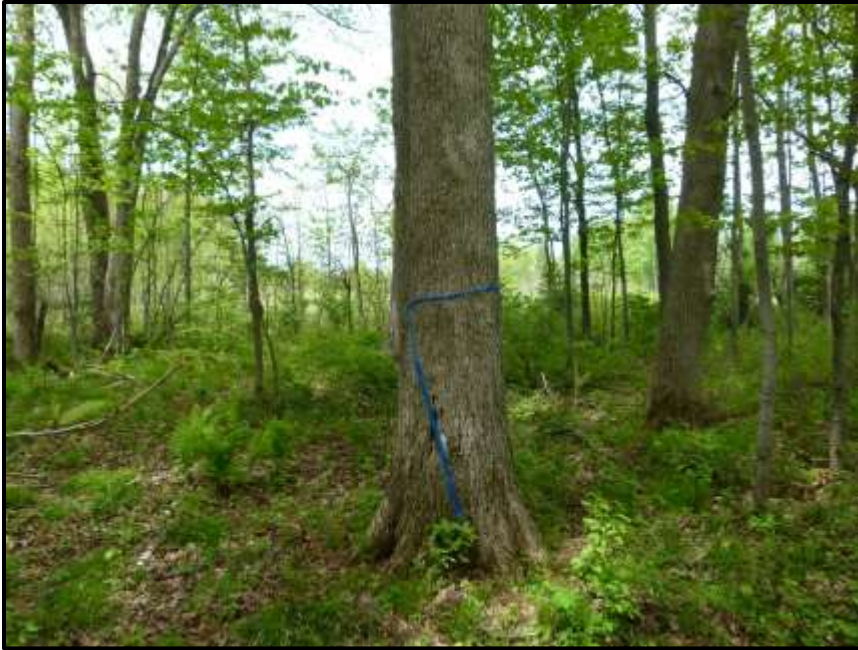
Photograph 35: Tree #36 – Bur Oak in good condition (May 27th, 2019).

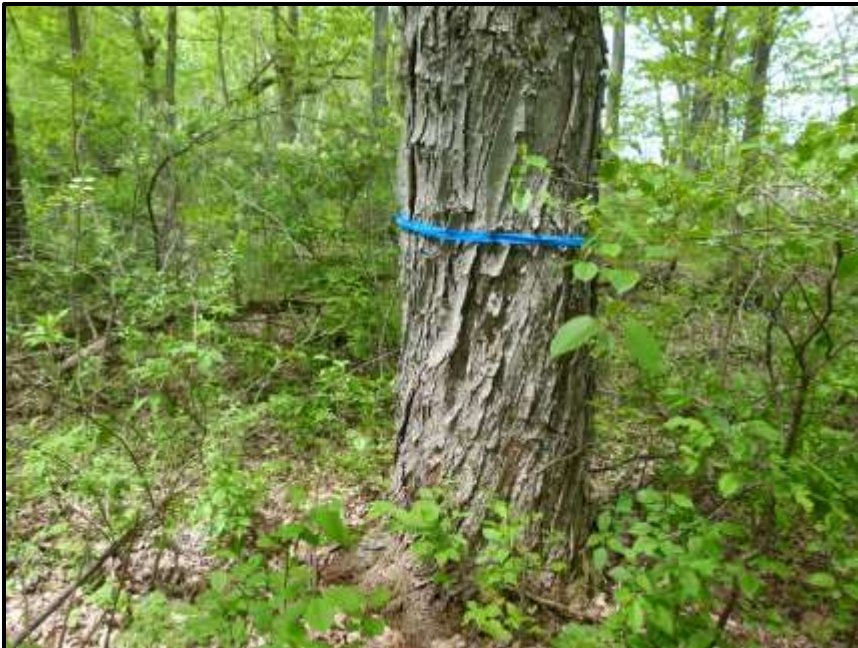
Photograph 38: Tree #39 – Sugar Maple in good condition (May 27th, 2019).

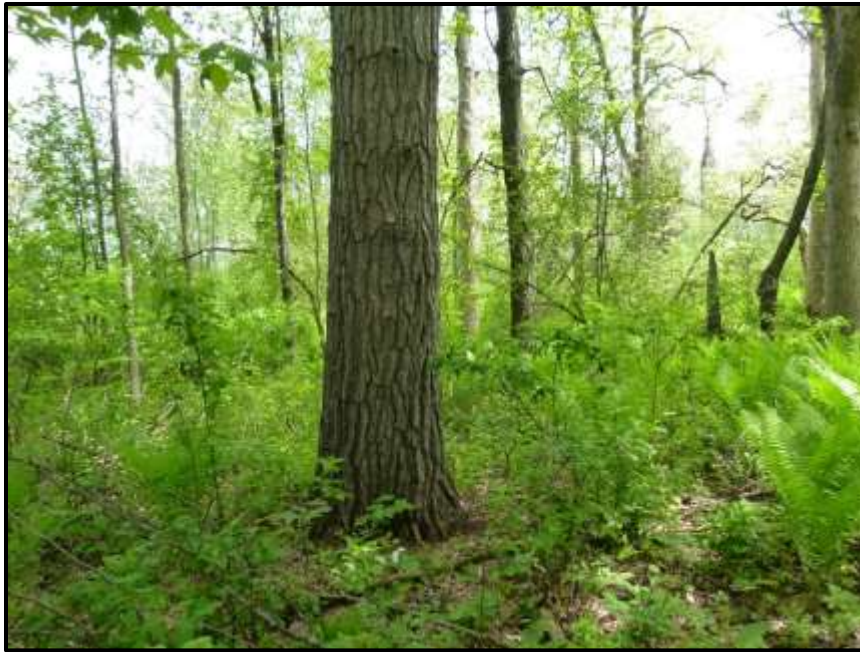
Photograph 39: Tree #40 – White Pine in good condition (May 27th, 2019).

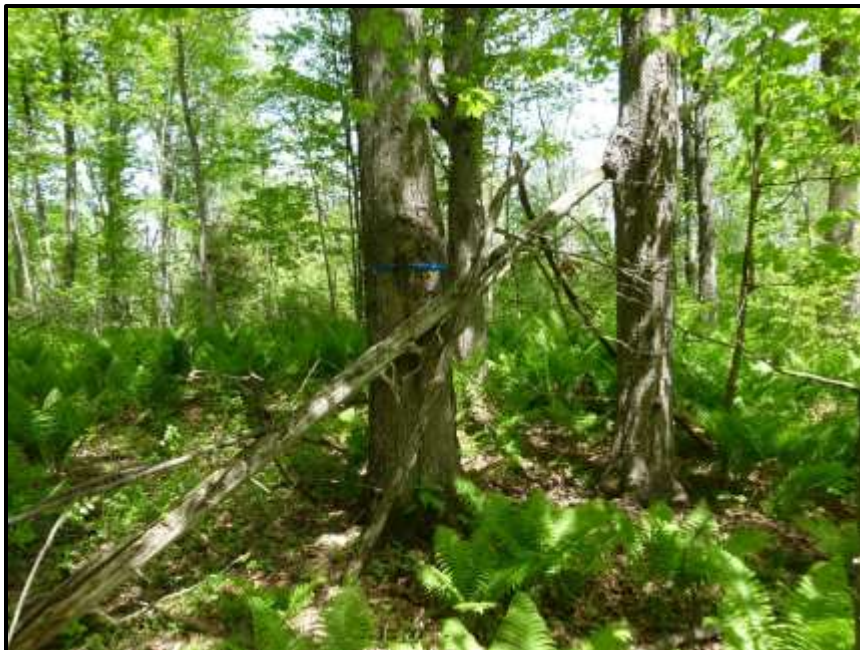
Photograph 40: Tree #41 – Sugar Maple in good condition (May 27th, 2019).

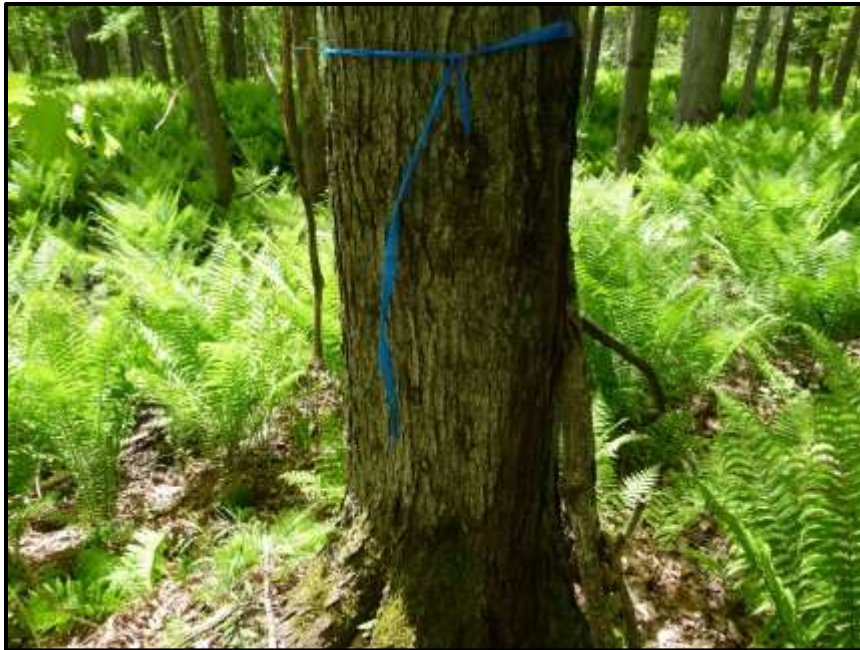
Photograph 41: Tree #42 – Sugar Maple in good condition (May 27th, 2019).

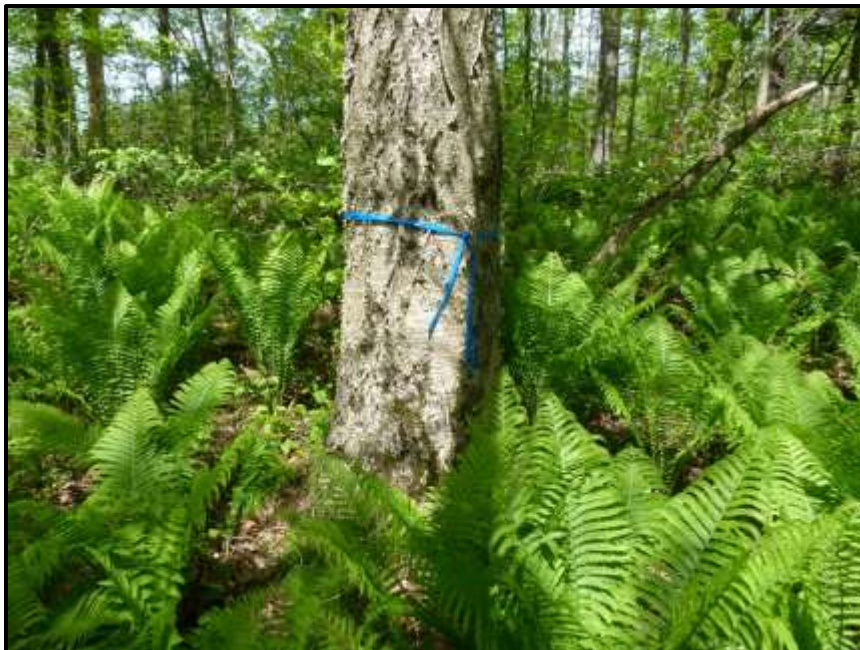
Photograph 42: Tree #43 – Yellow Birch in good condition (May 27th, 2019).

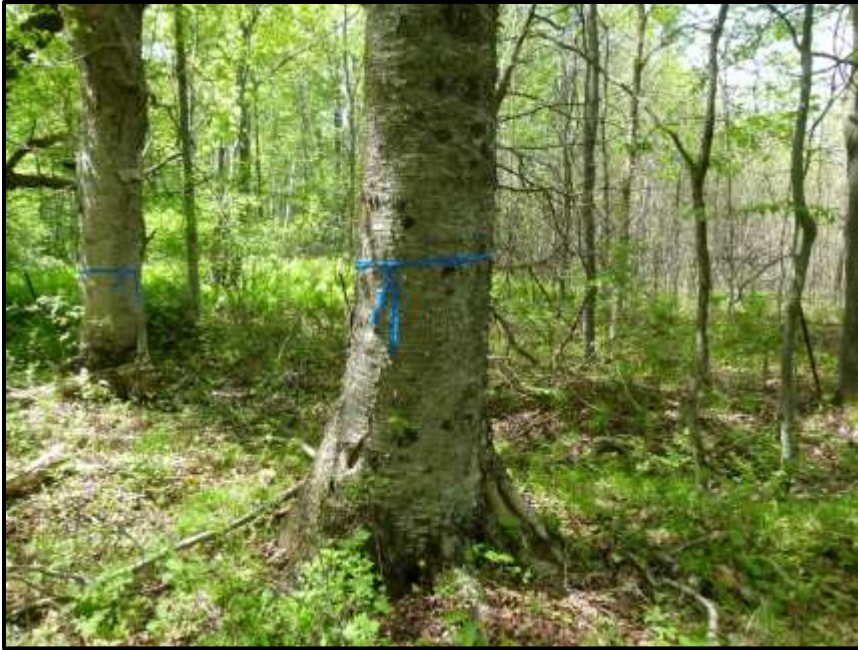
Photograph 43: Tree #44 – Yellow Birch in good condition (May 27th, 2019).

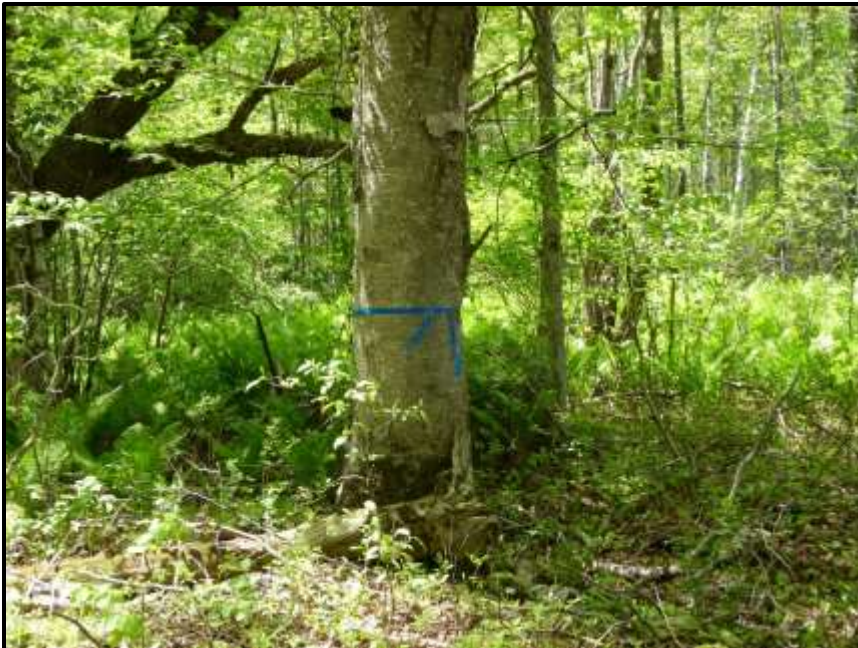
Photograph 44: Tree #45 – Yellow Birch in good condition (May 27th, 2019).

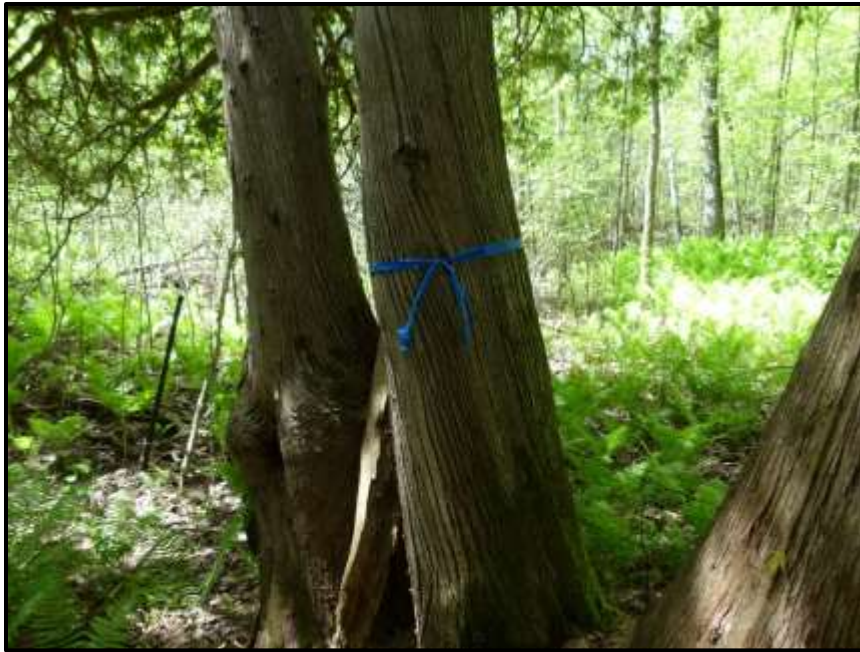
Photograph 45: Tree #46 – White Cedar in good condition (May 27th, 2019).

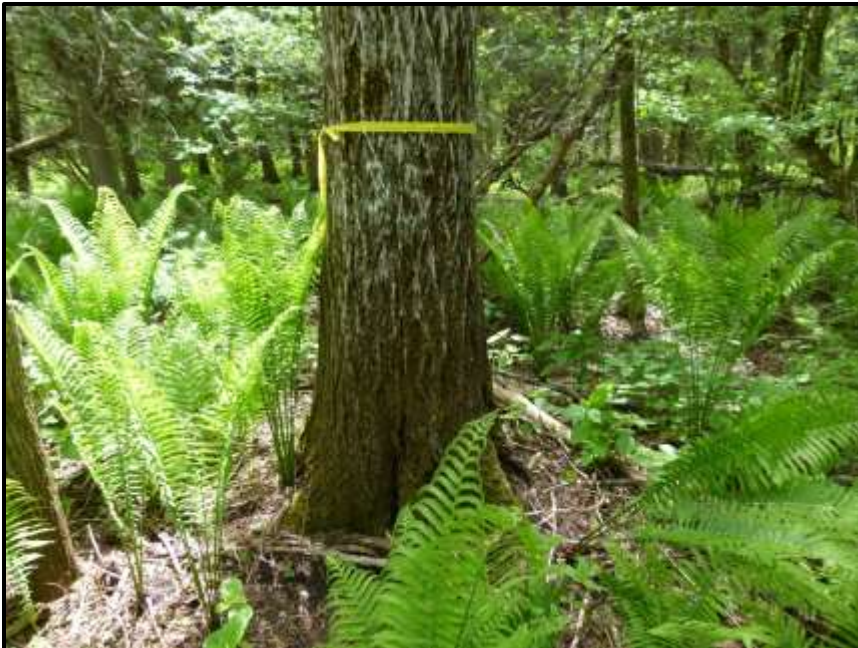
Photograph 52: Tree #53 – Category 3 Butternut (May 27th, 2019).

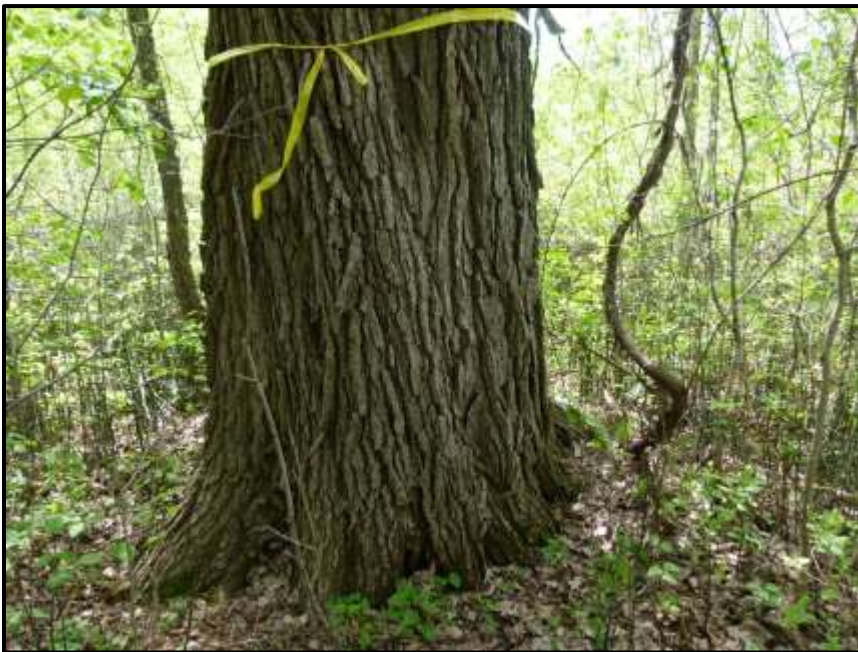
Photograph 54: Tree #55 – Bur Oak in good condition (May 30th, 2019).

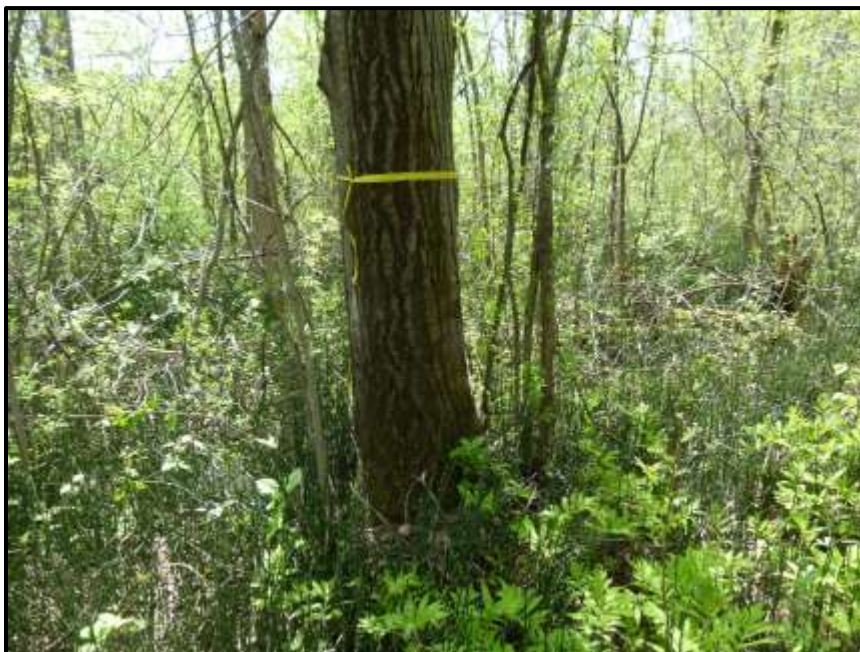
Photograph 56: Tree #57 – Trembling Aspen in good condition (May 30th, 2019).

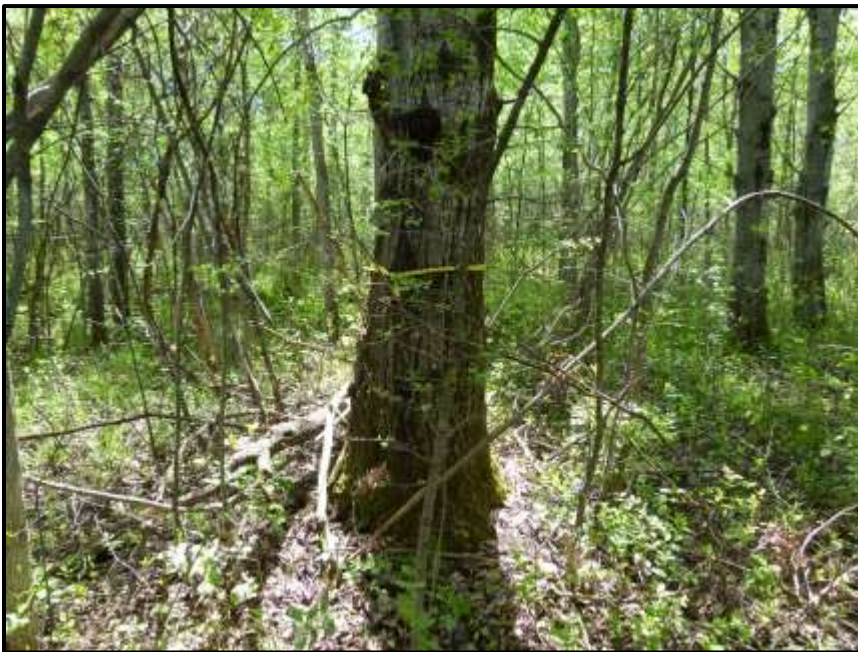
Photograph 58: Tree #59 – Trembling Aspen in good condition (May 30th, 2019).

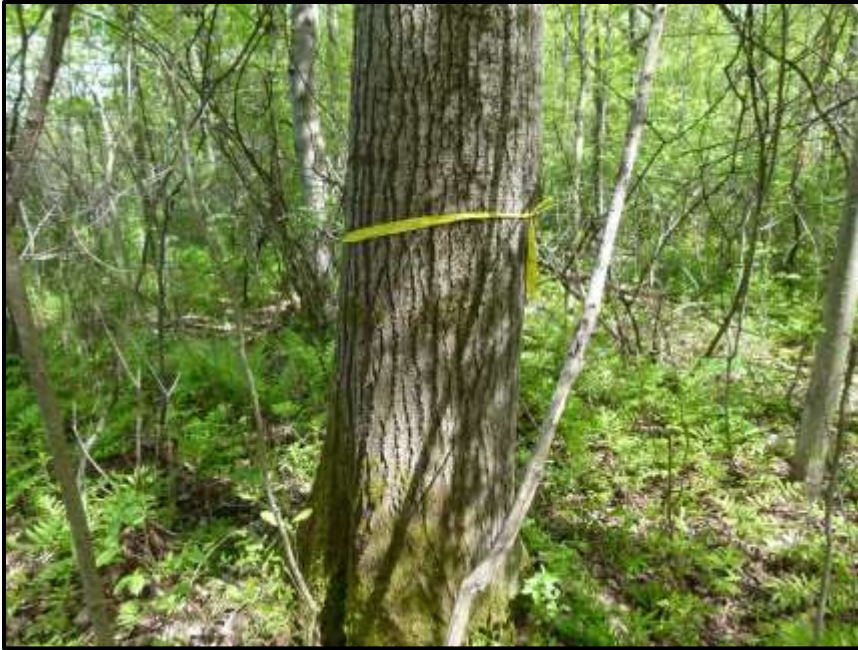
Photograph 59: Tree #60 – Trembling Aspen in good condition (May 30th, 2019).

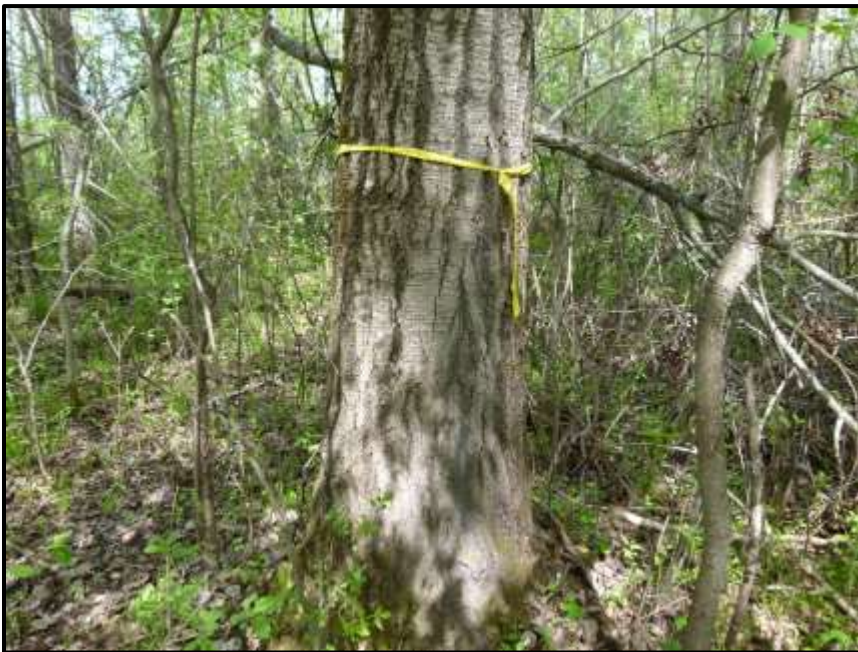
Photograph 60: Tree #61 – Trembling Aspen in good condition (May 30th, 2019).

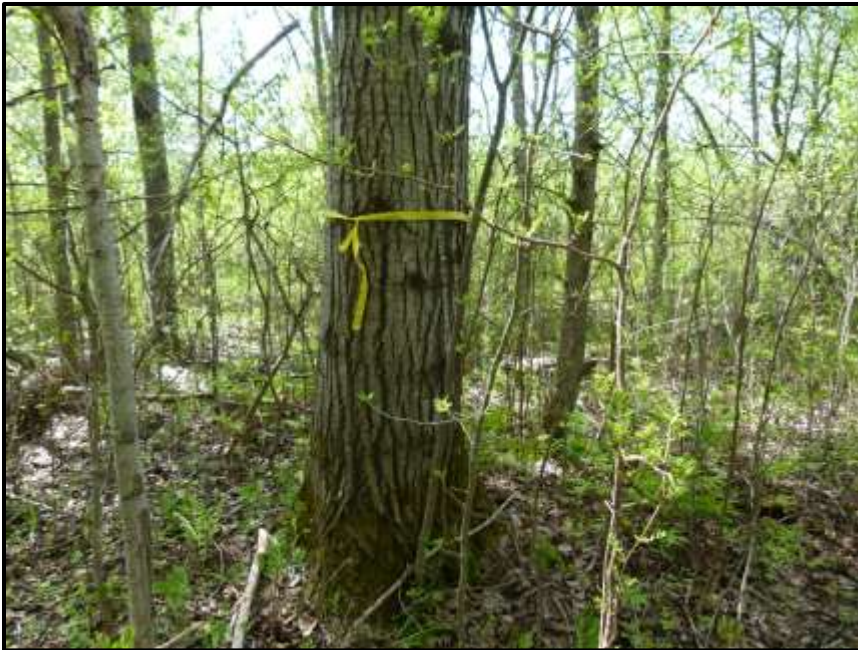
Photograph 61: Tree #62 – Trembling Aspen in good condition (May 30th, 2019).

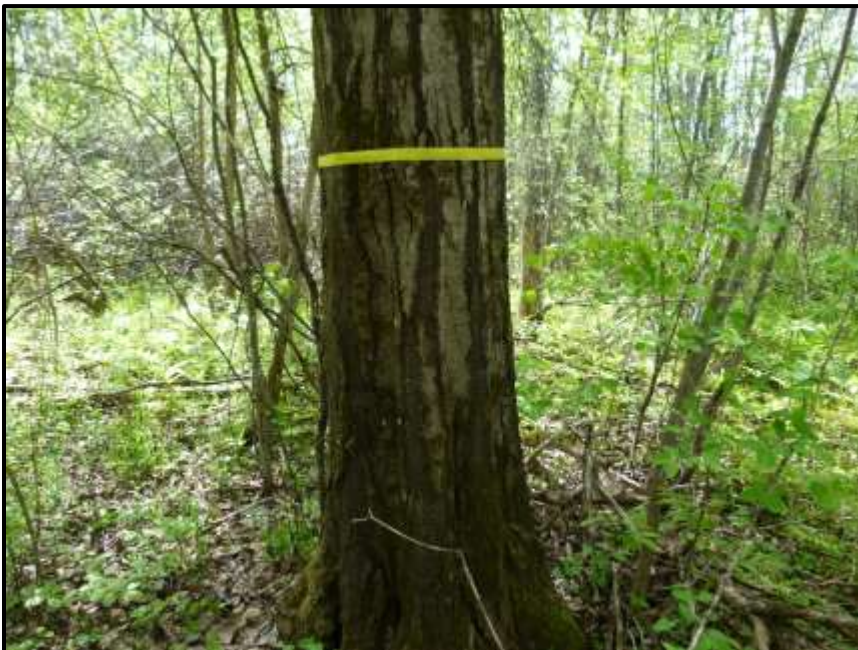
Photograph 62: Tree #63 – Trembling Aspen in good condition (May 30th, 2019).

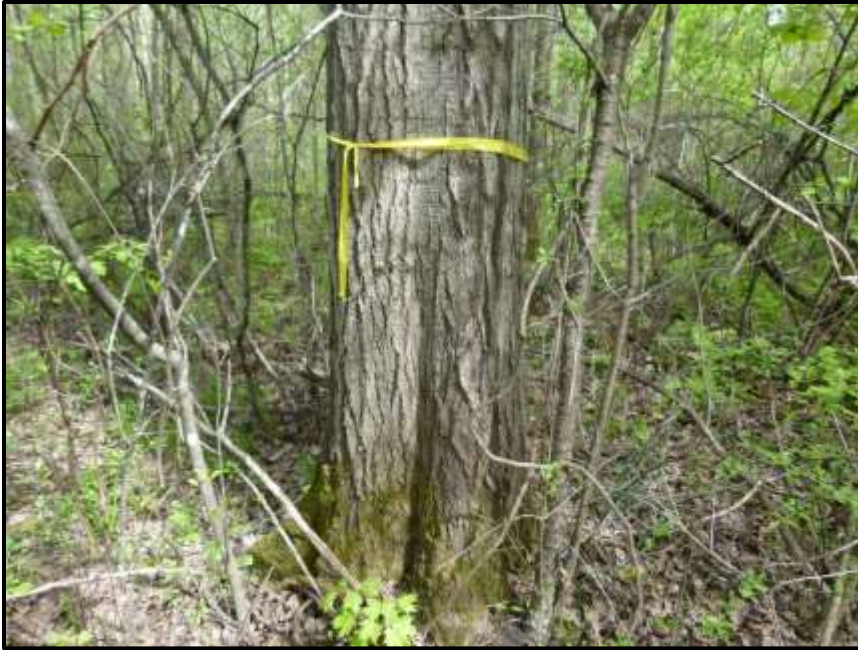
Photograph 63: Tree #64 – Trembling Aspen in good condition (May 30th, 2019).

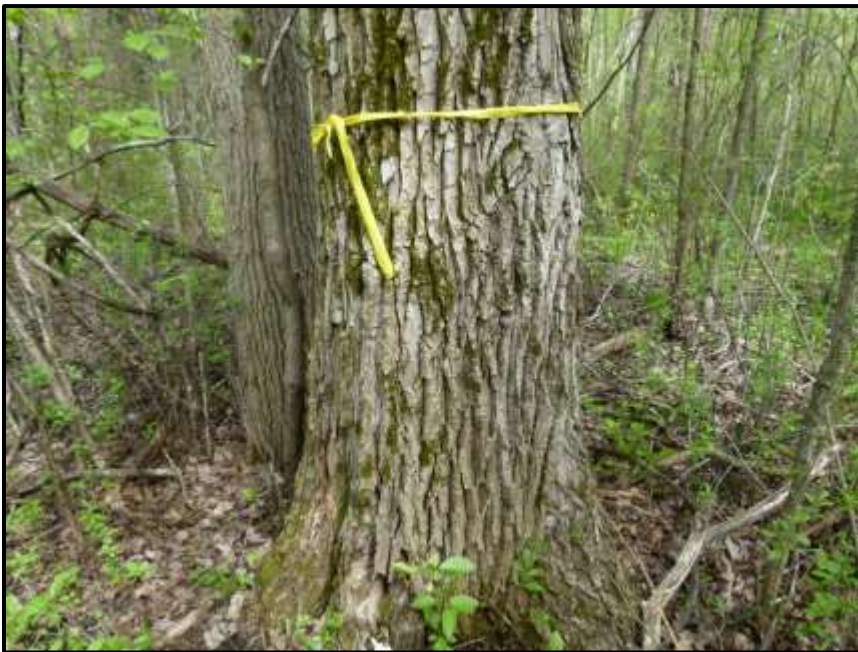
Photograph 64: Tree #65 – Trembling Aspen in good condition (May 30th, 2019).

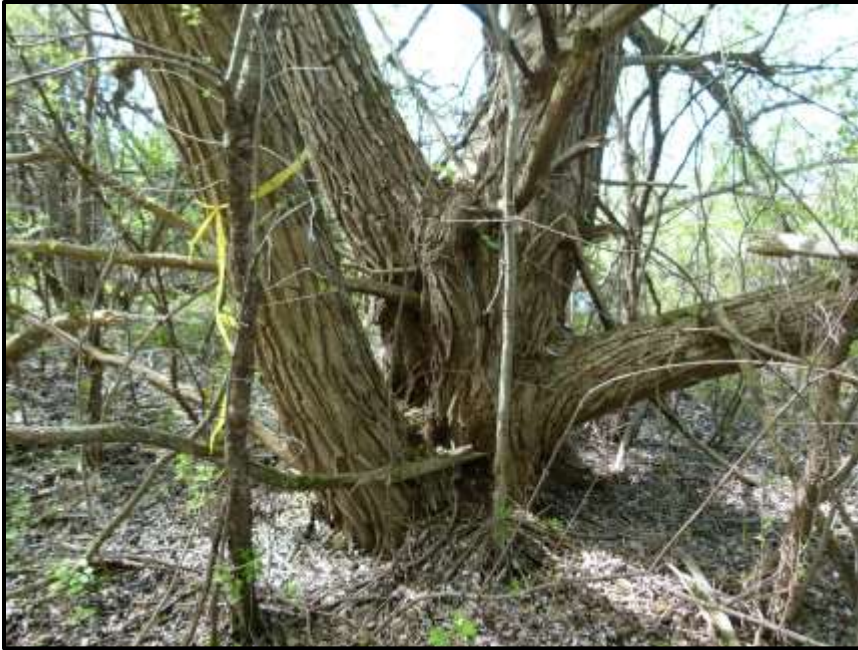
Photograph 65: Tree #66 – Crack Willow in good condition (May 30th, 2019).

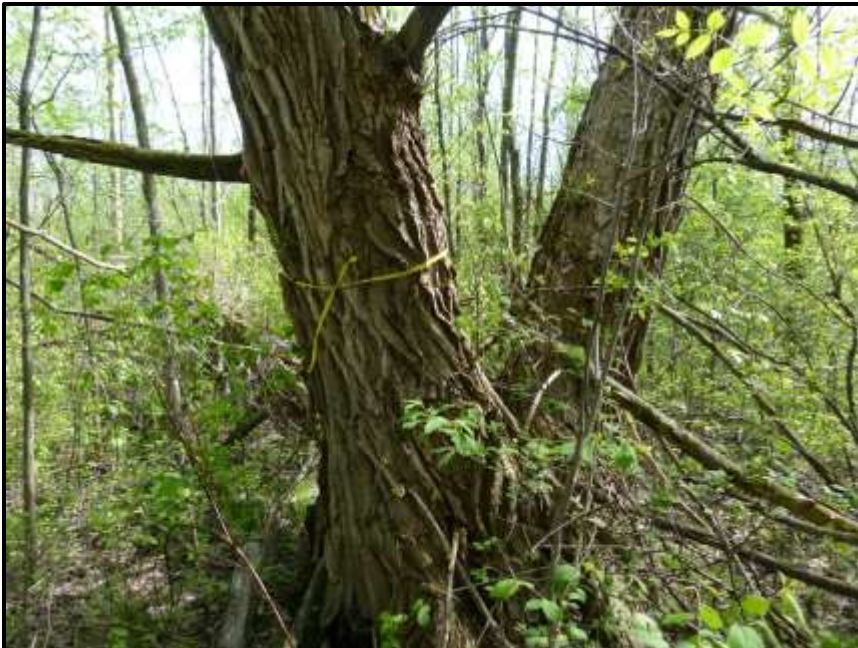
Photograph 66: Tree #67 – Crack Willow in good condition (May 30th, 2019).

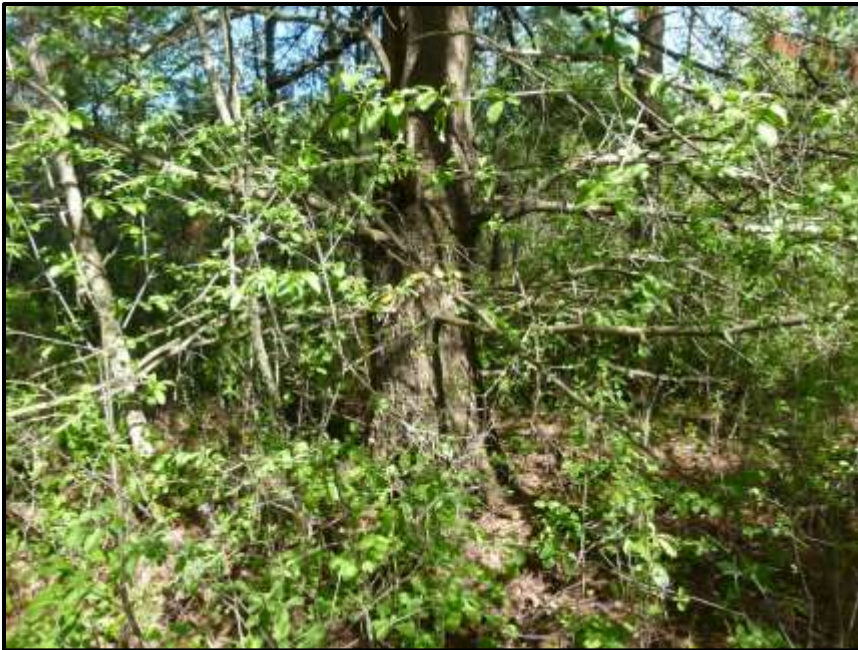
Photograph 67: Tree #68 – White Pine in good condition (May 30th, 2019).
