June 3rd, 2019

RE: Woodlot S-23 Large Tree Inventory – Minto Communities and Valecraft Homes Kanata North
Developments

APPENDIX A – TREE PHOTOS

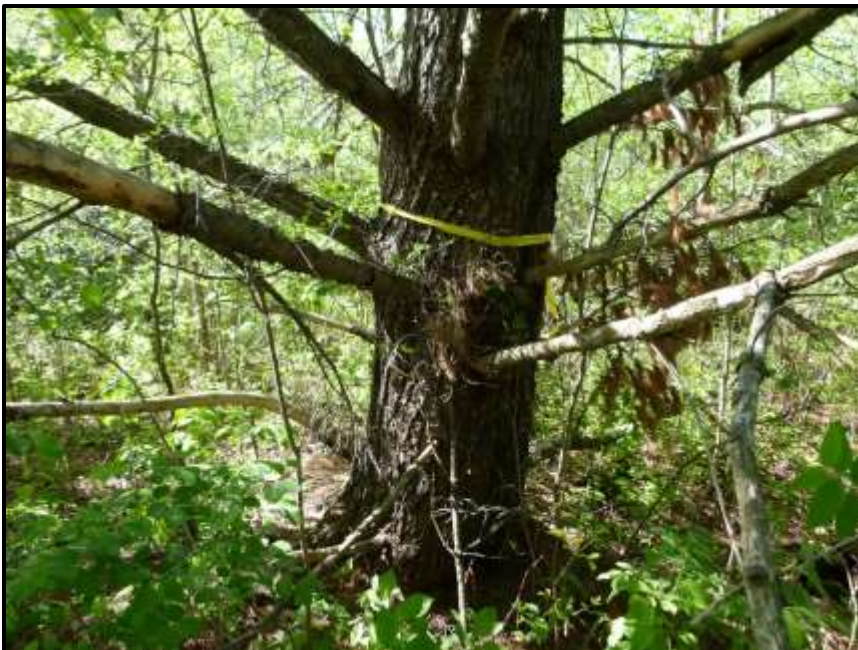
Photograph 68: Tree #69 – White Pine in good condition (May 30th, 2019).

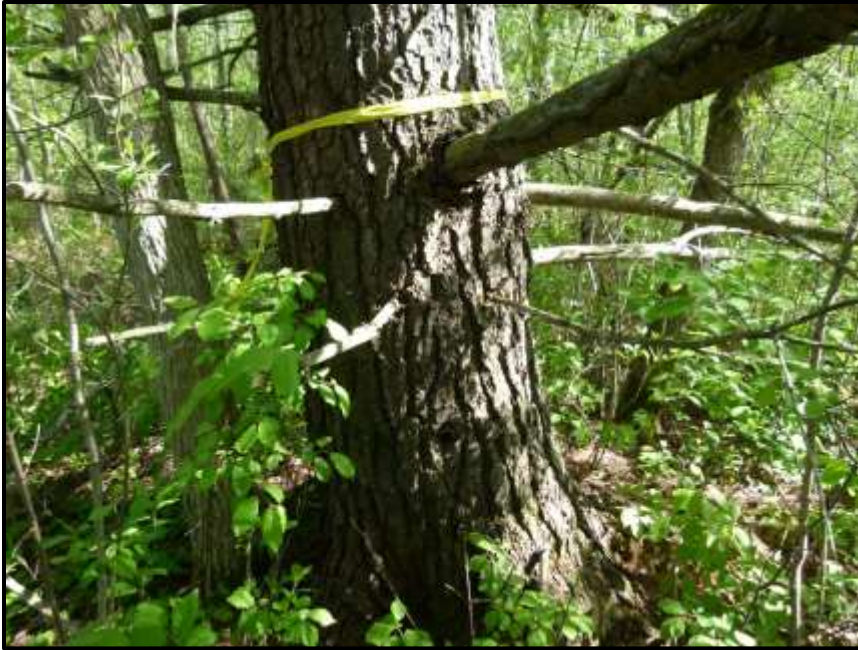
Photograph 69: Tree #70 – White Pine in good condition (May 30th, 2019).

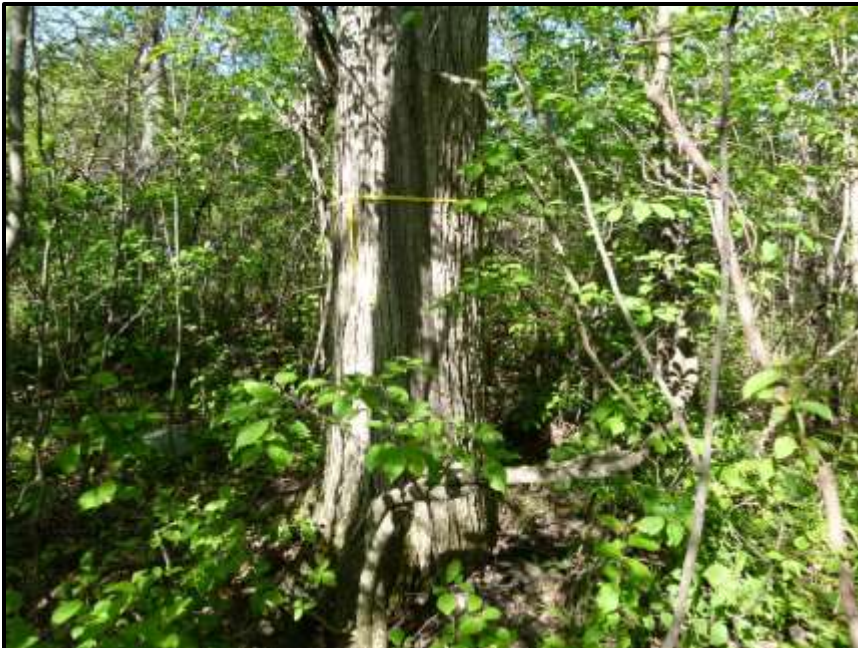
Photograph 70: Tree #71 – White Pine in good condition (May 30th, 2019).
