# **Landslide Hazard Assessment**

## **Proposed Residential Development**

Old Montreal Road  
Ottawa, Ontario

Report PG5201-2 Revision 5 dated December 20, 2024

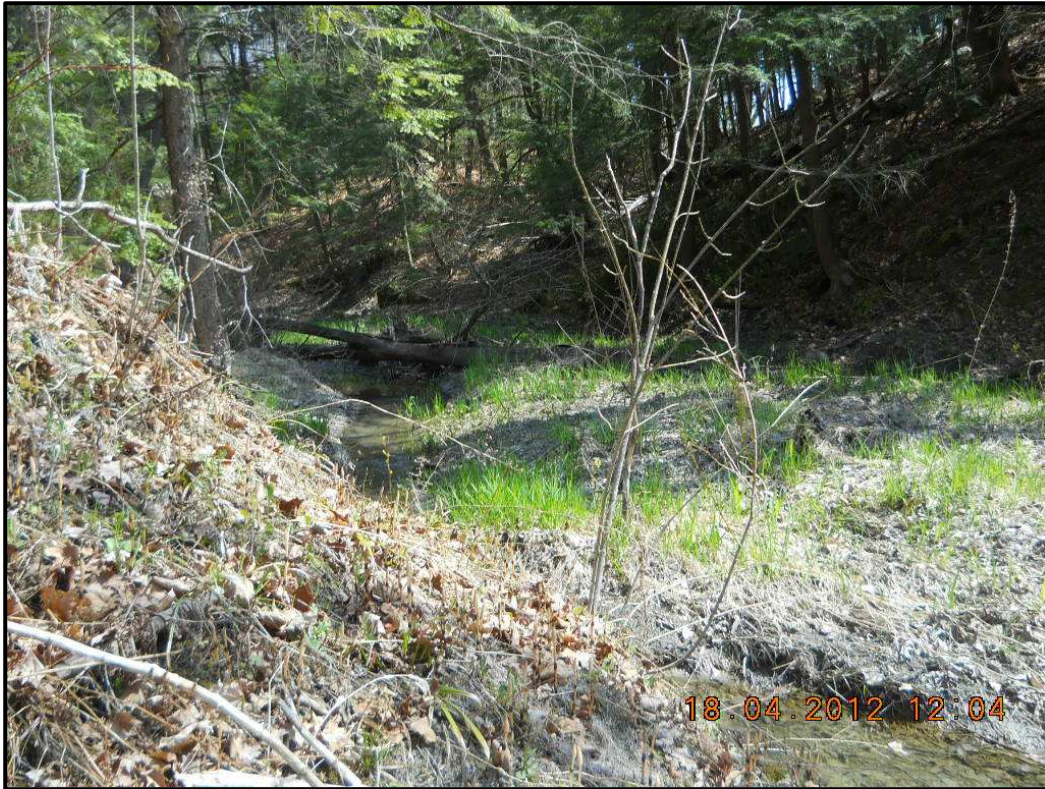
Photo 1A: Photo taken on April 18, 2012 from the north bank of the valley corridor wall along the South Tributary looking east (upstream) near Section I.

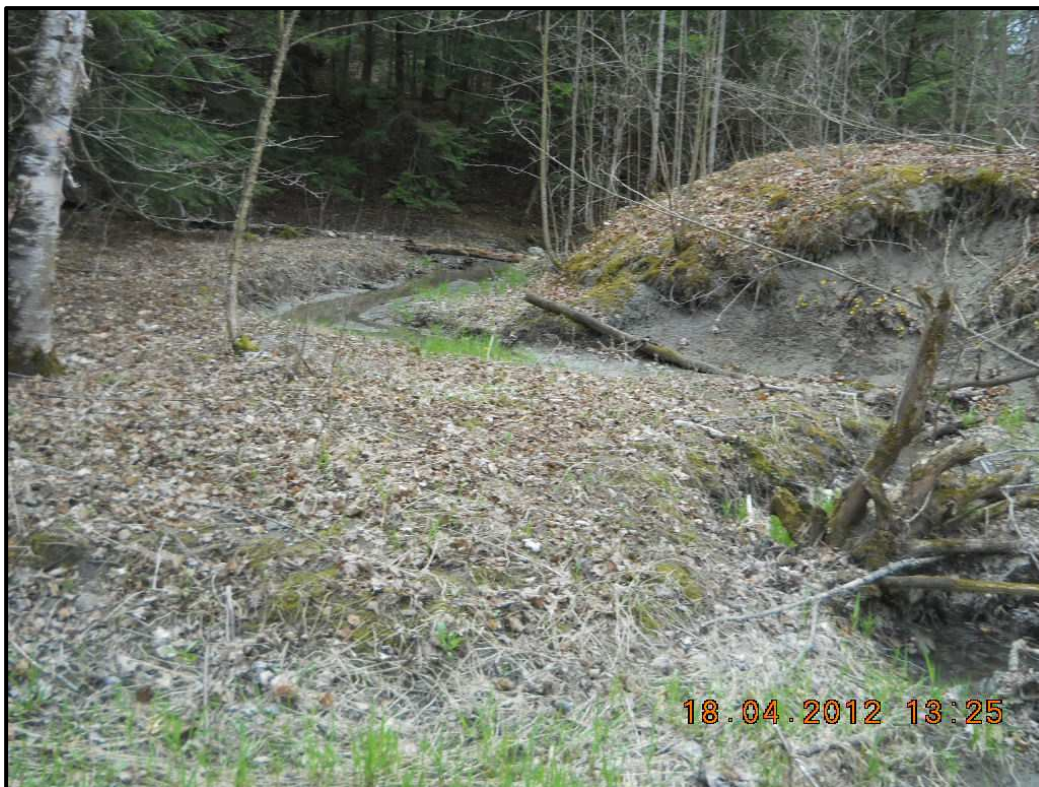
Photo 4: Photo taken on April 18, 2012 from the south bank of the South Tributary looking west (downstream) near Section F.

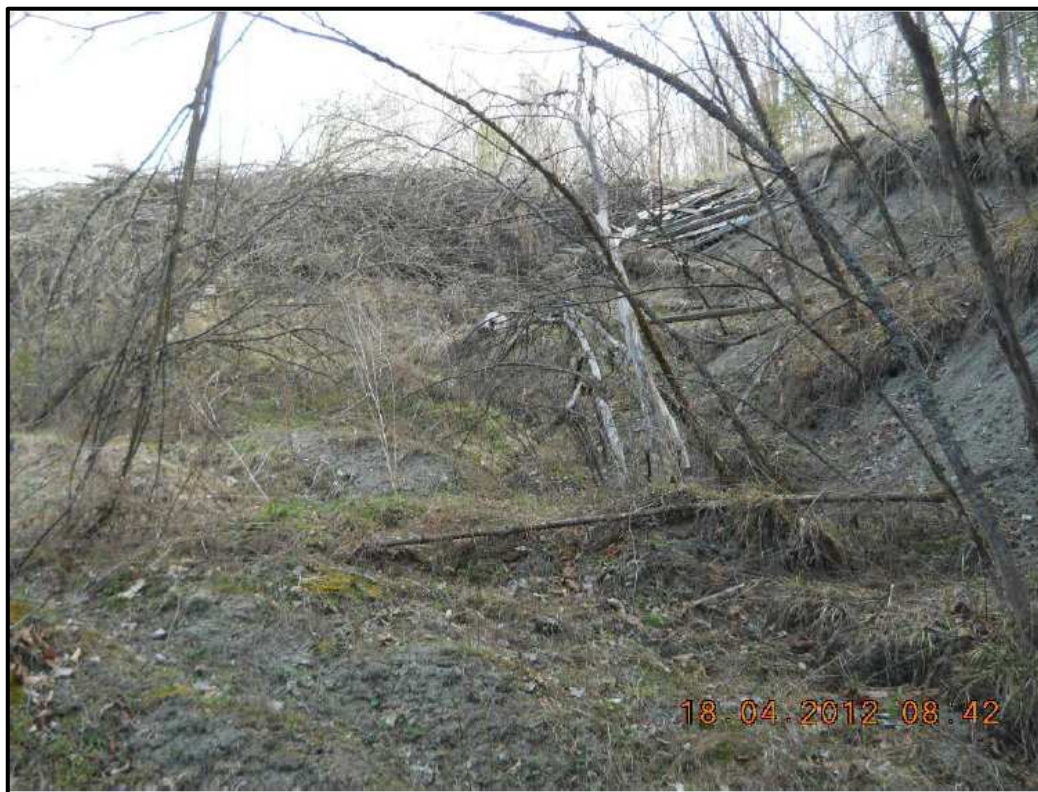
Photo 5: Photo taken on April 18, 2012 of the east bank of the valley corridor along Mid-Branch 1, north of Section J.

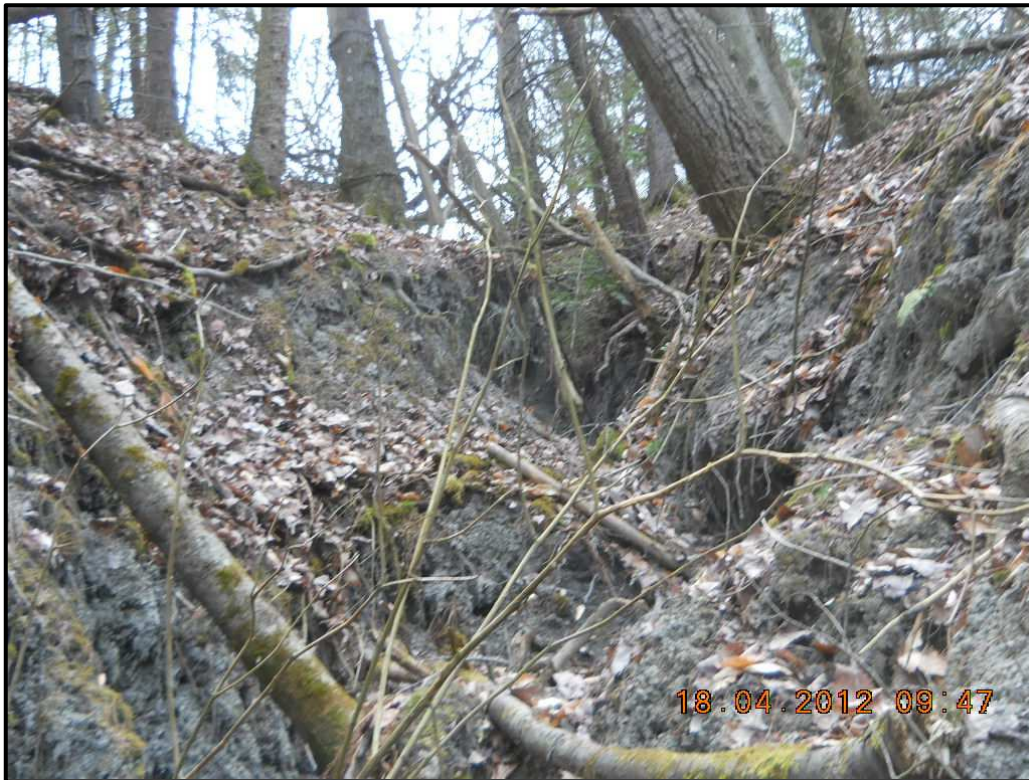
Photo 7A: Photo taken on April 18, 2012 of the drainage ravine near Section K.

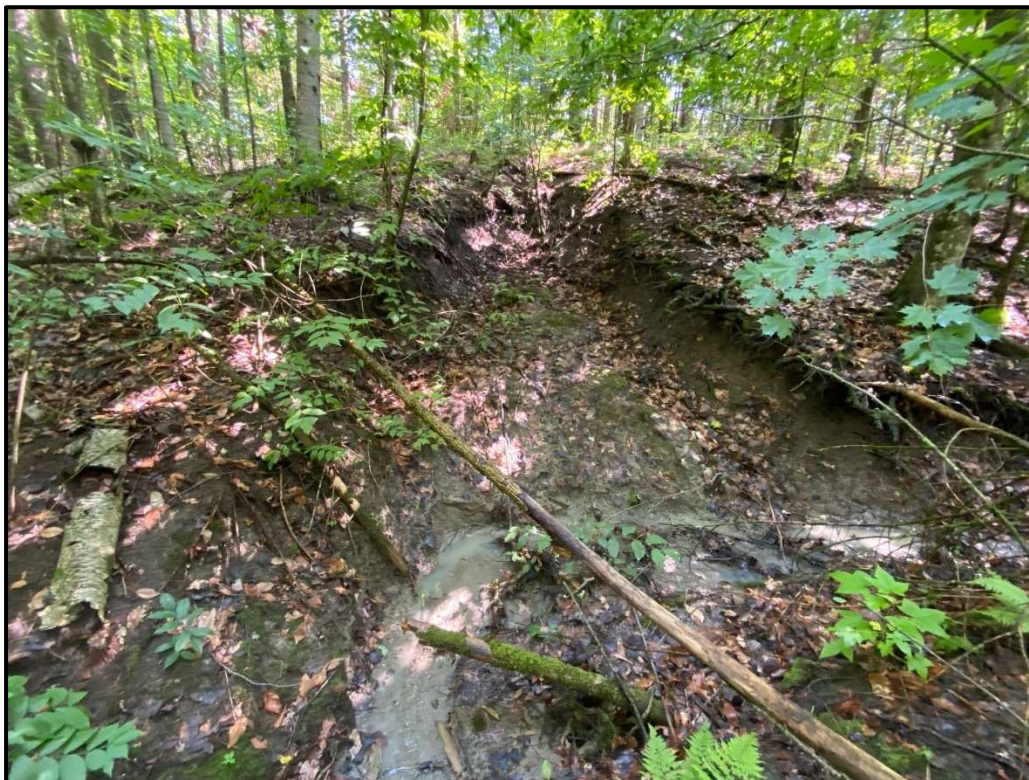
Photo 7B: Photo taken on July 19, 2023 of the drainage ravine near Section K.

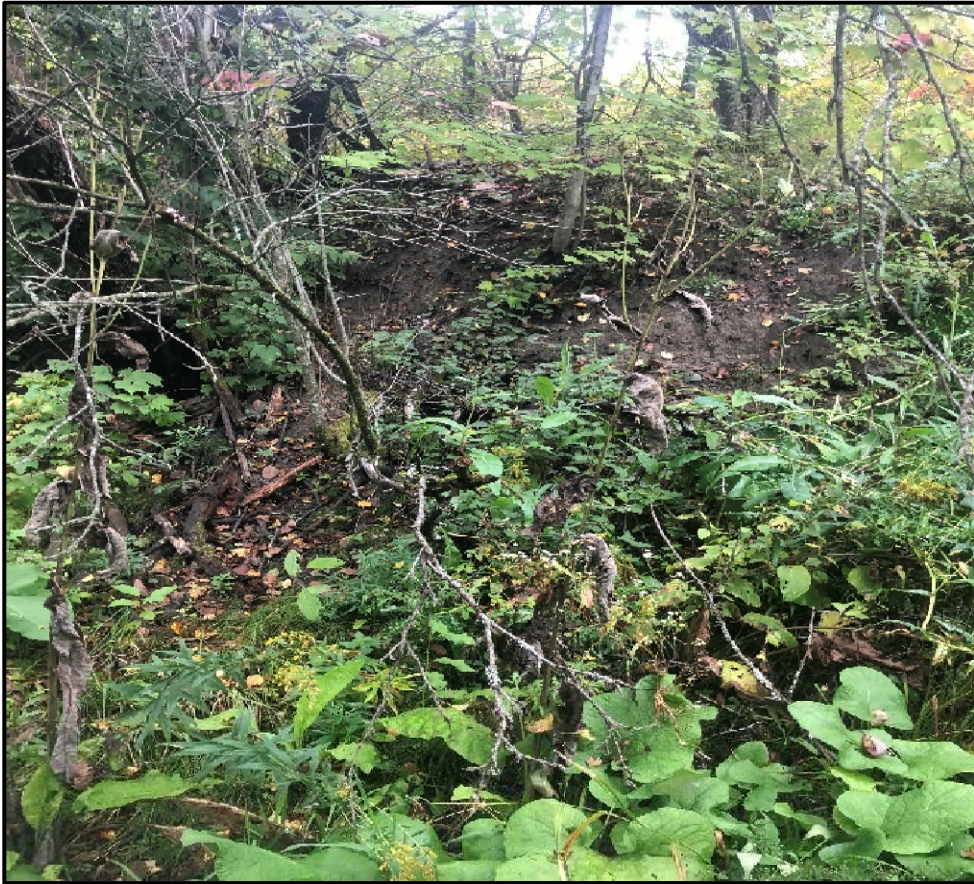
Photo 8A: Photo taken on September 10, 2020 of the north slope face, looking northwest.

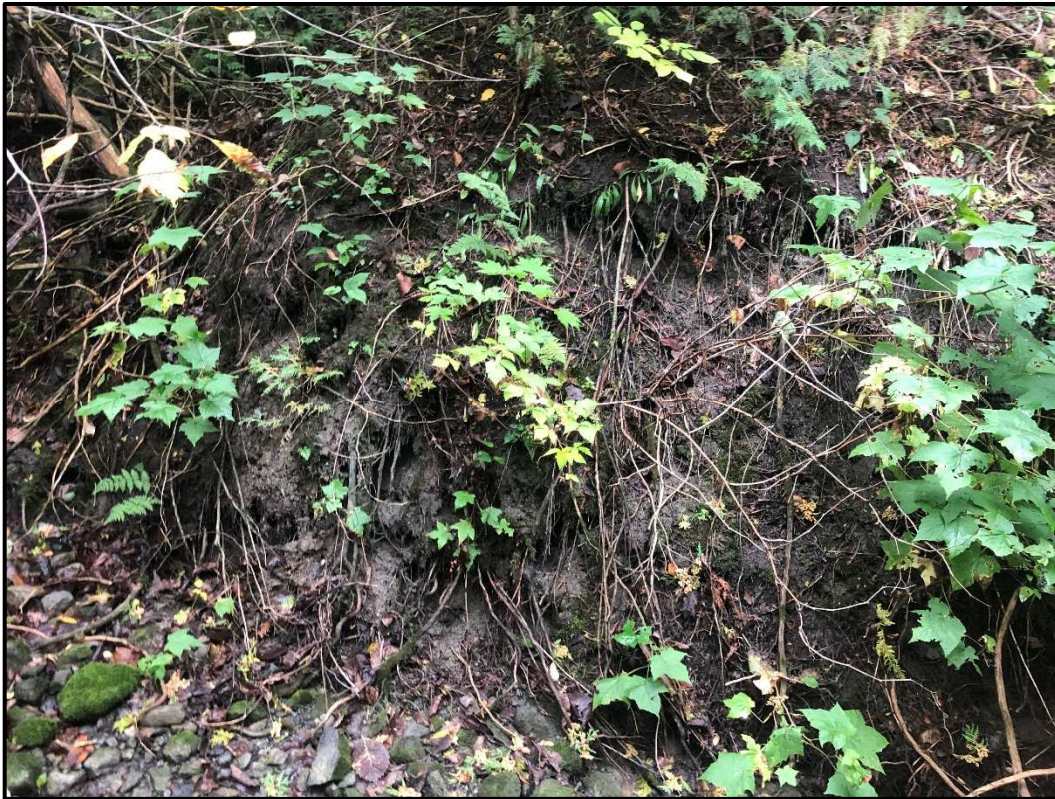
Photo 9A: Photo taken on September 10, 2020 of the north slope face, looking northwest.

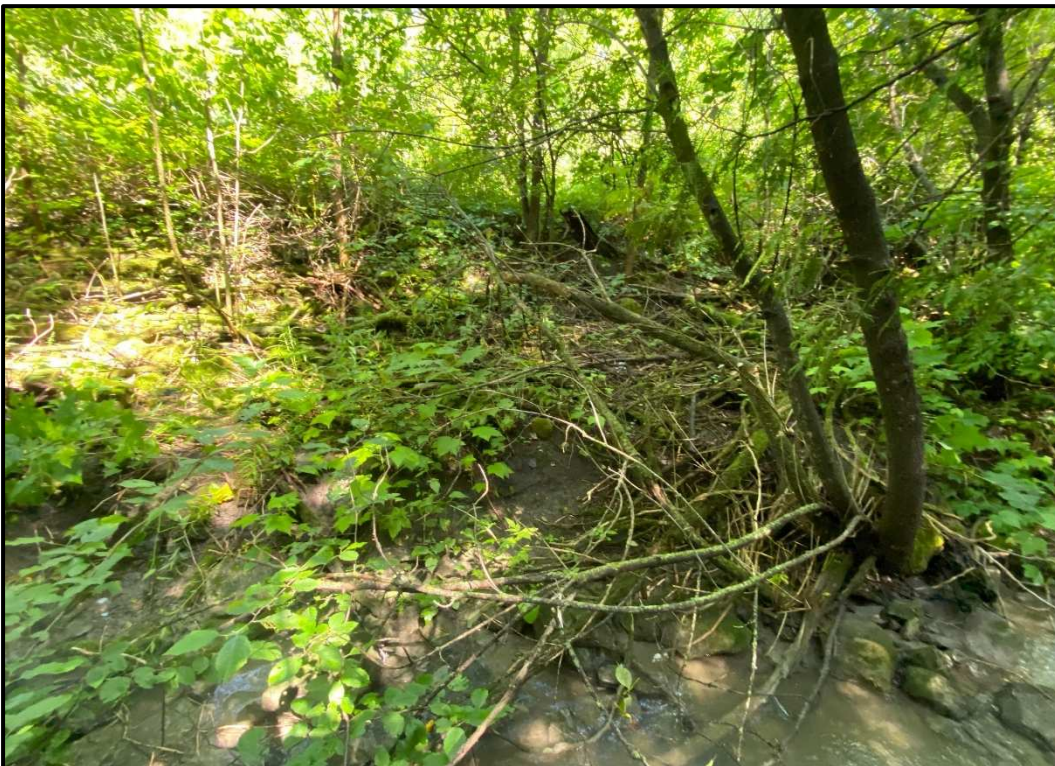
Photo 9B: Photo taken on July 19, 2023 of the north slope face, looking northwest.

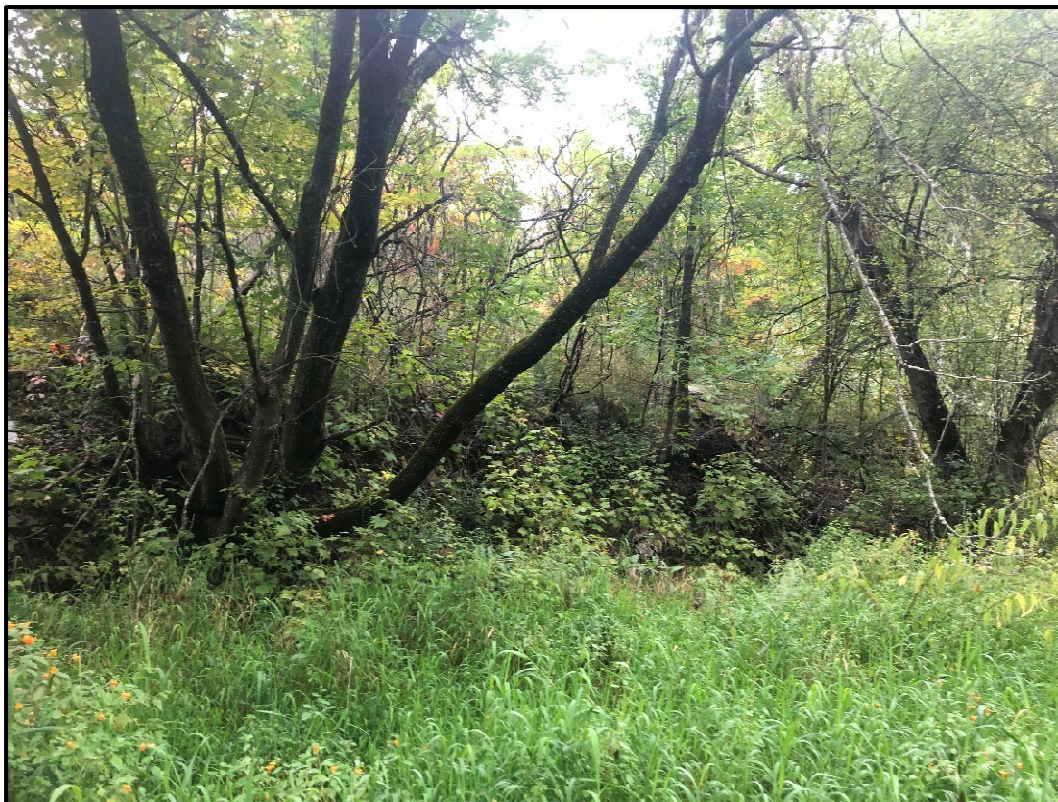
Photo 10A: Photo taken on September 10, 2020 of the north slope face, looking north.

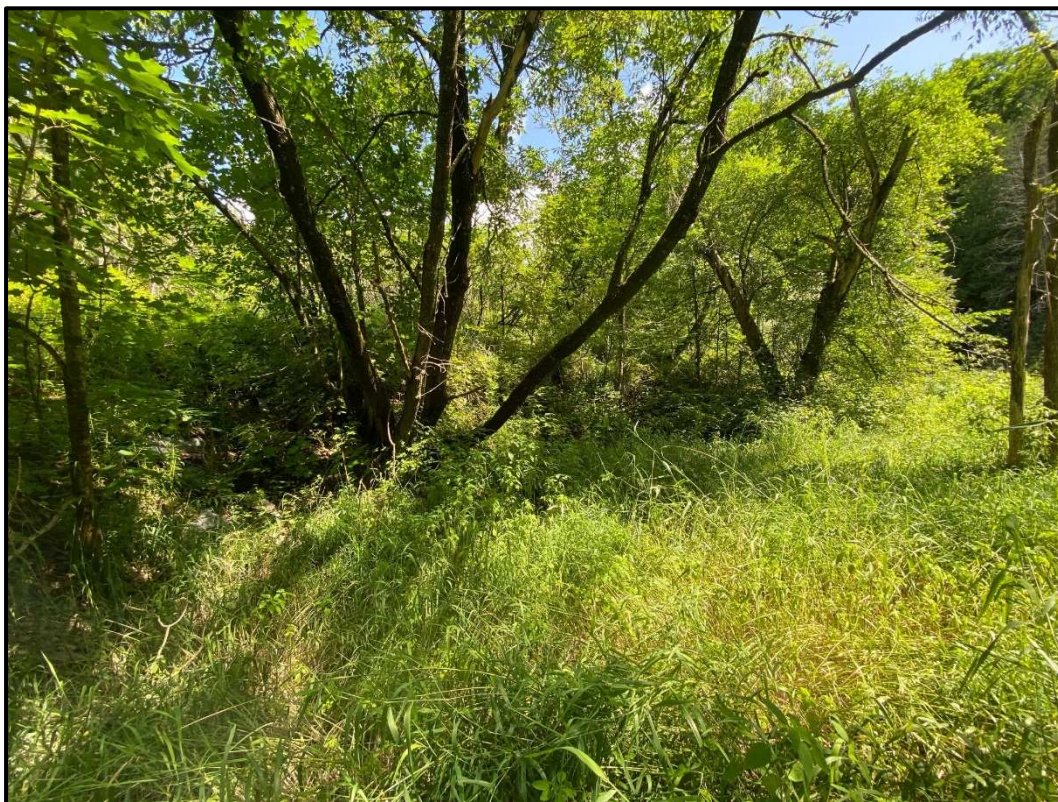
Photo 10B: Photo taken on July 19, 2023 of the north slope face, looking north.

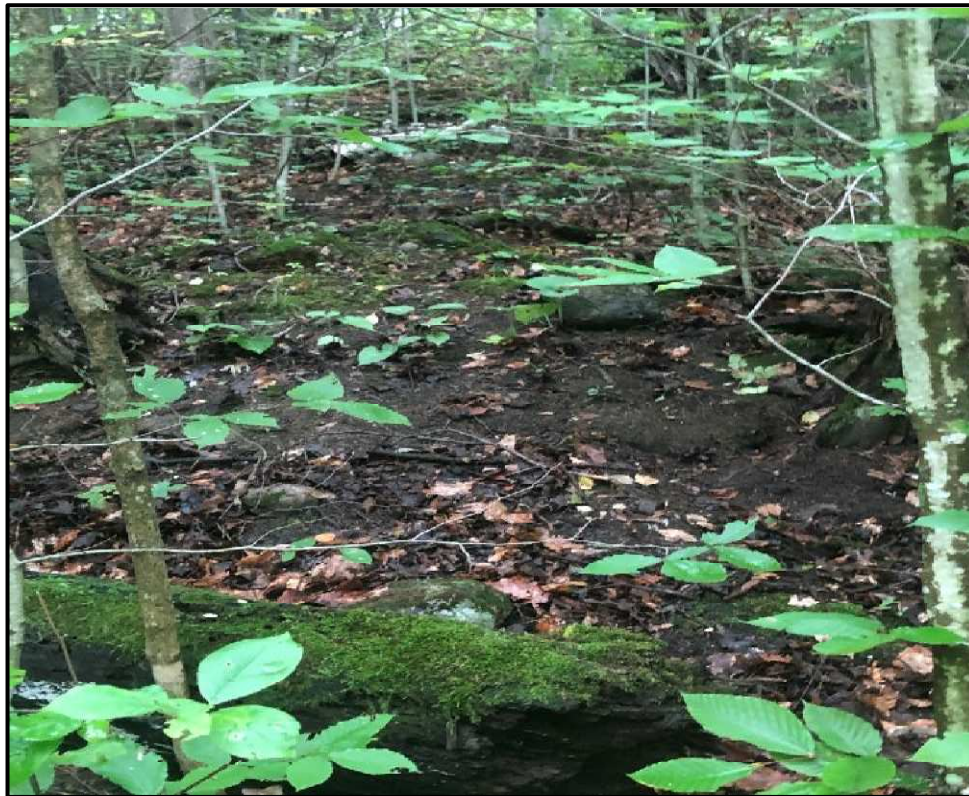
Photo 11A: Photo taken on September 10, 2020 of the south slope face looking southeast near Section O

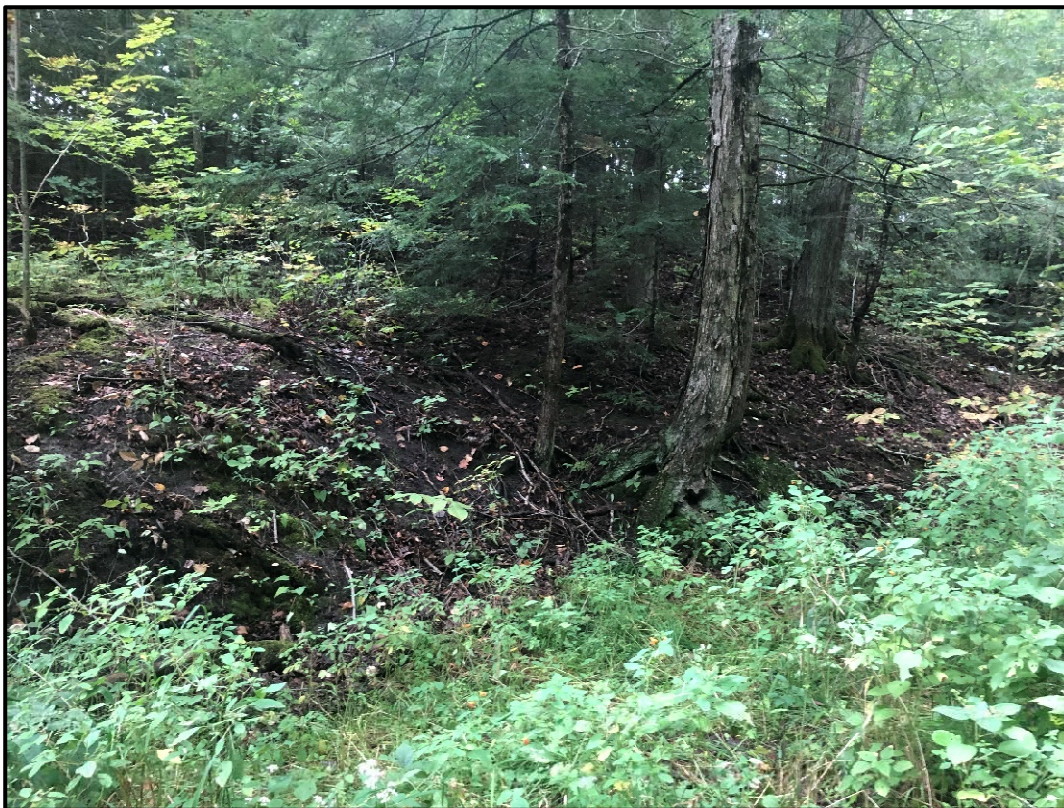
Photo 12A: Photo taken on September 10, 2020 of the north slope face, looking northwest.

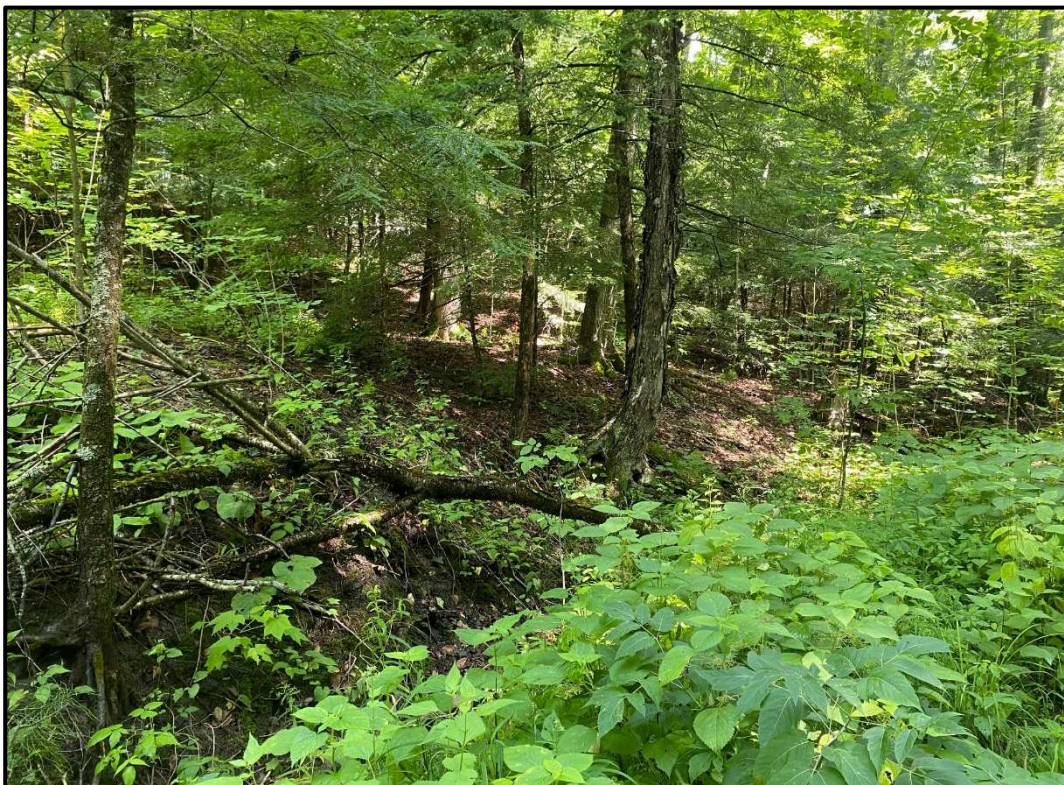
Photo 12B: Photo taken on July 19, 2023 of the north slope face, looking northwest.

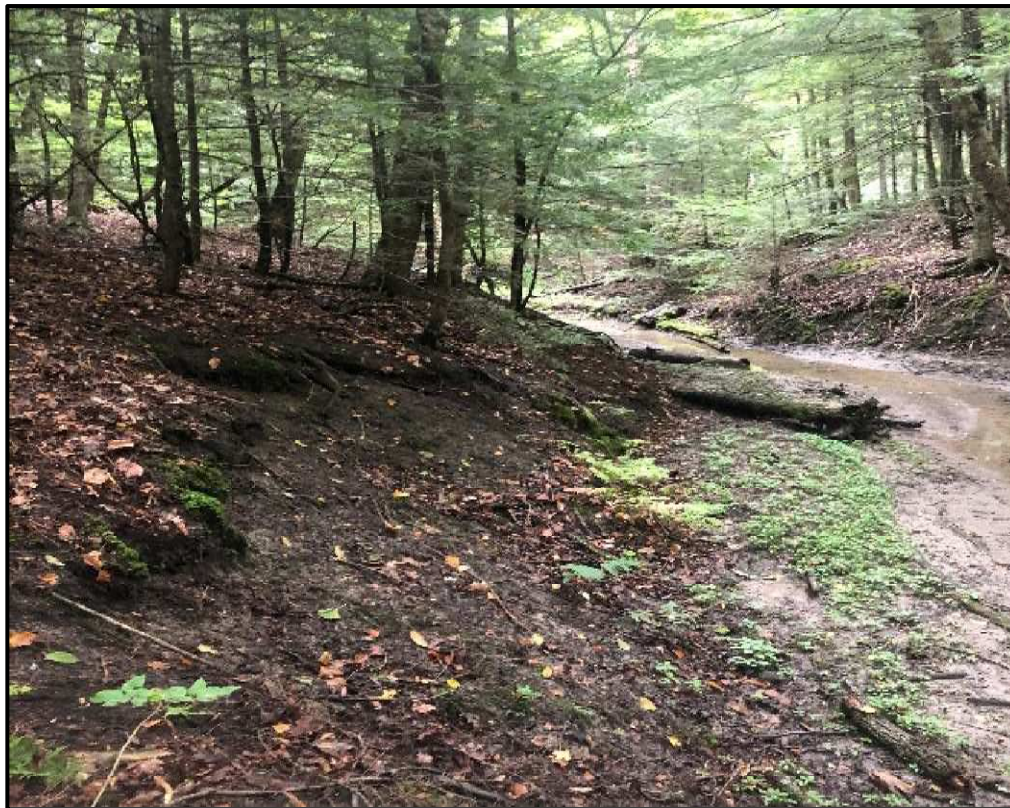
Photo 13A: Photo taken on September 10, 2020 of the north slope face, looking east (upstream) near Section H.

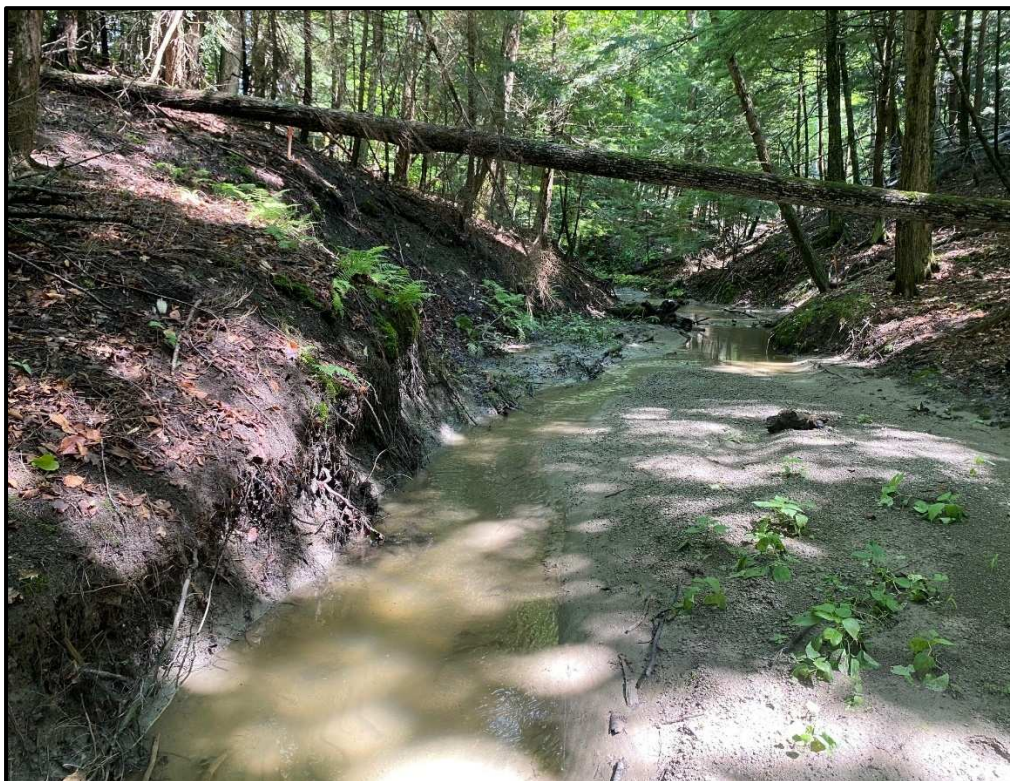
Photo 13B: Photo taken on July 19, 2023 of the north slope face, looking east (upstream) near Section H.

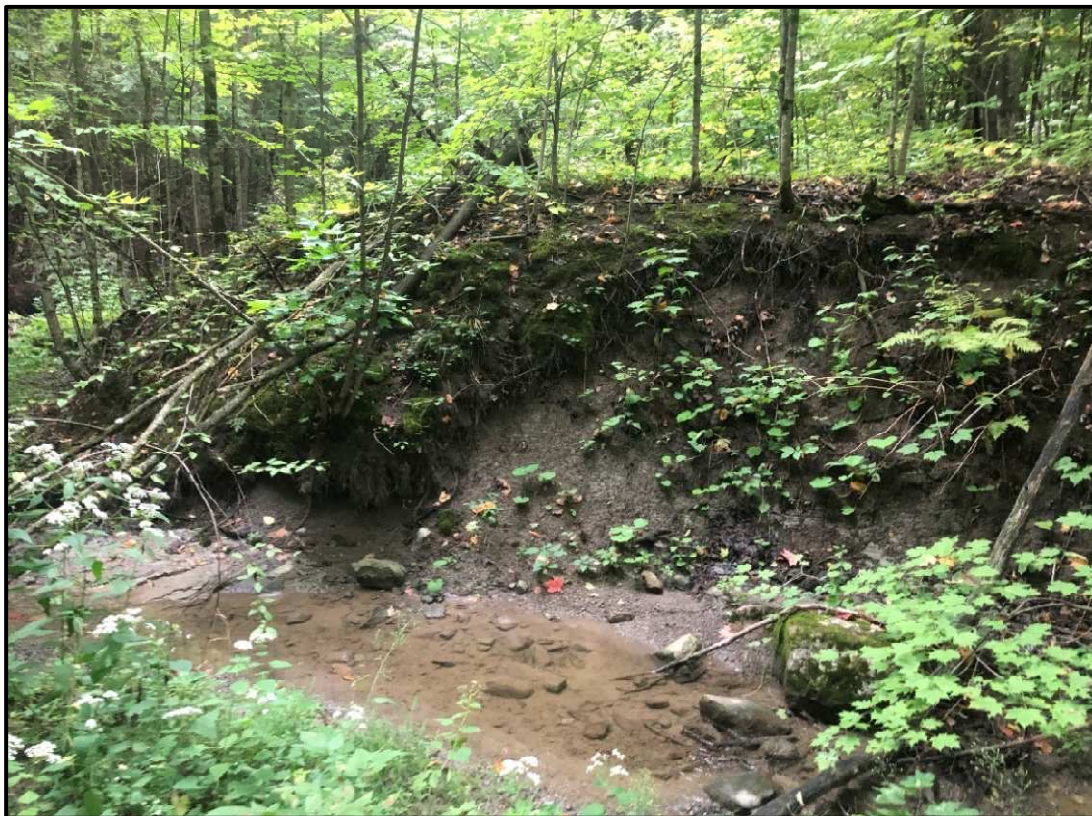
Photo 16A: Photo taken on September 10, 2020 of the south slope face near section HH.

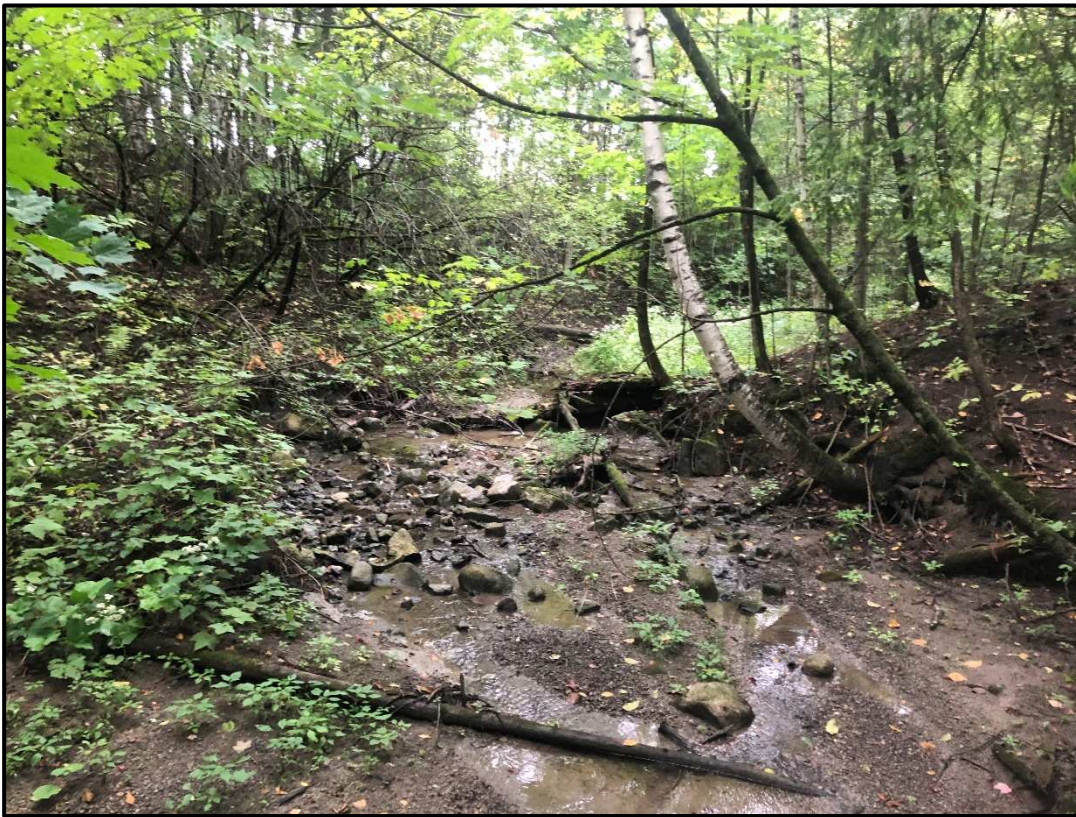
Photo 17A: Photo taken on September 10, 2020 along the watercourse, looking east (upstream).

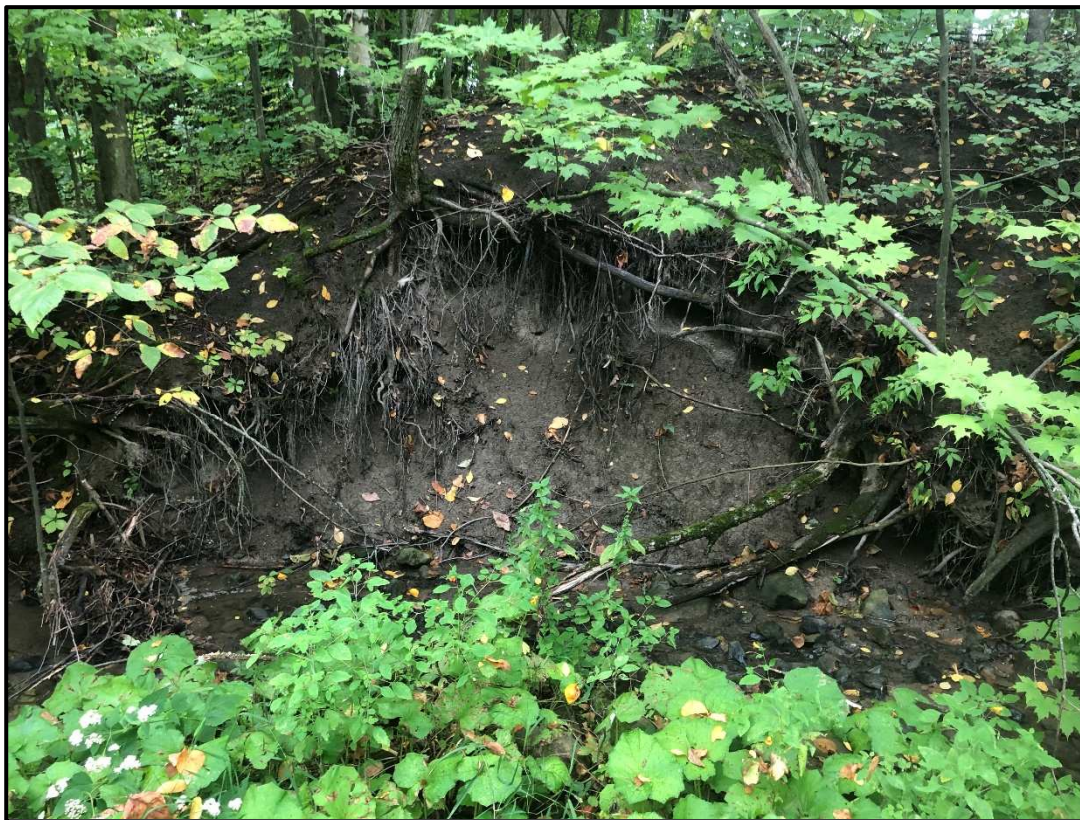
Photo 18A: Photo taken on September 10, 2020 of the north slope face, looking north at section GG.

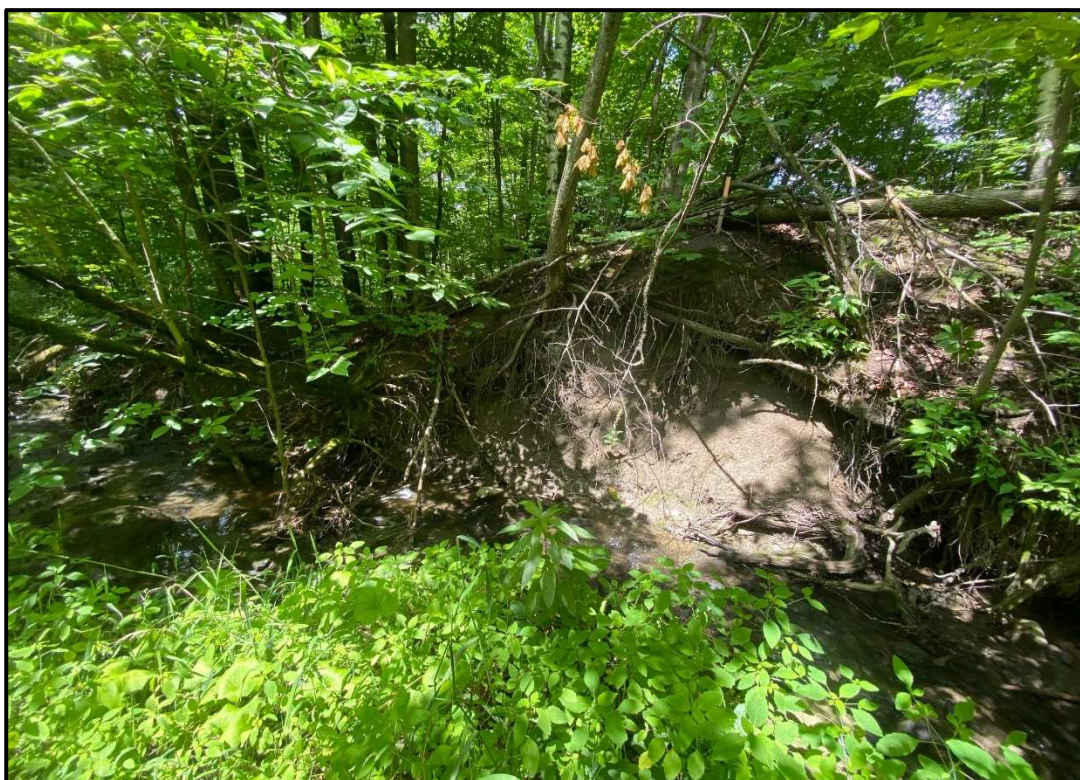
Photo 18B: Photo taken on July 19, 2023 of the north slope face, looking north at section GG.

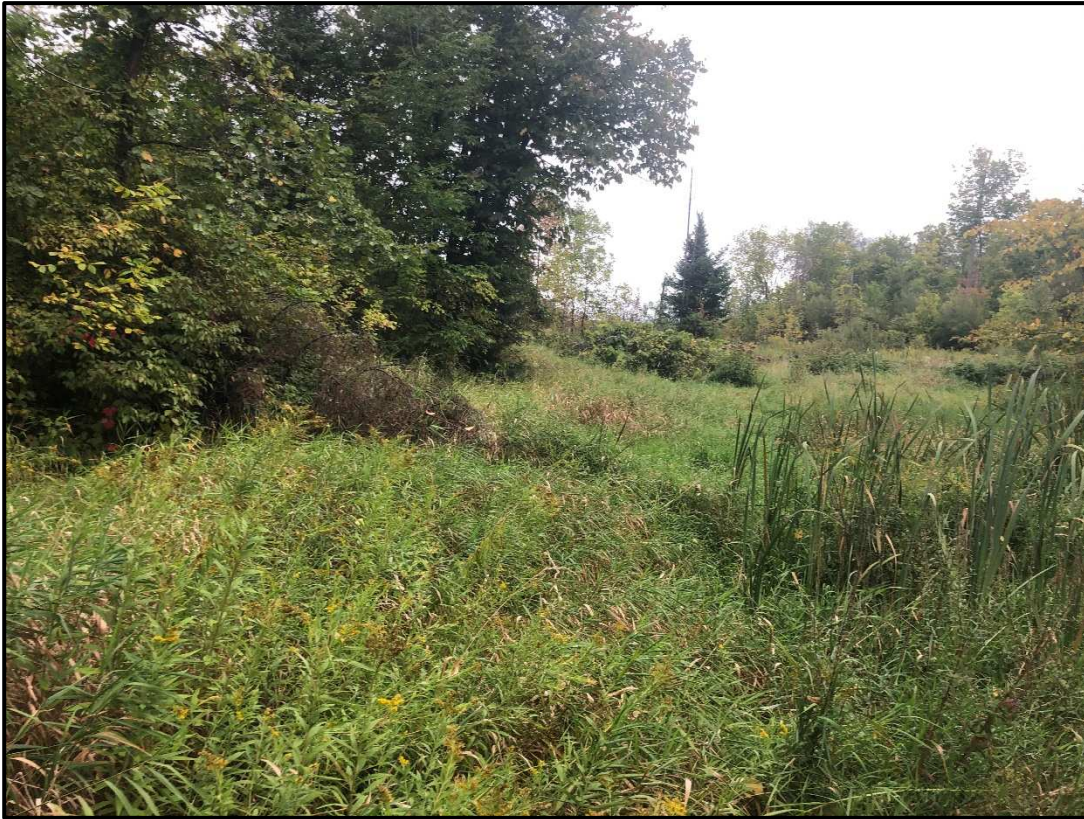
Photo 19A: Photo taken on September 10, 2020 along the watercourse, looking east (upstream).

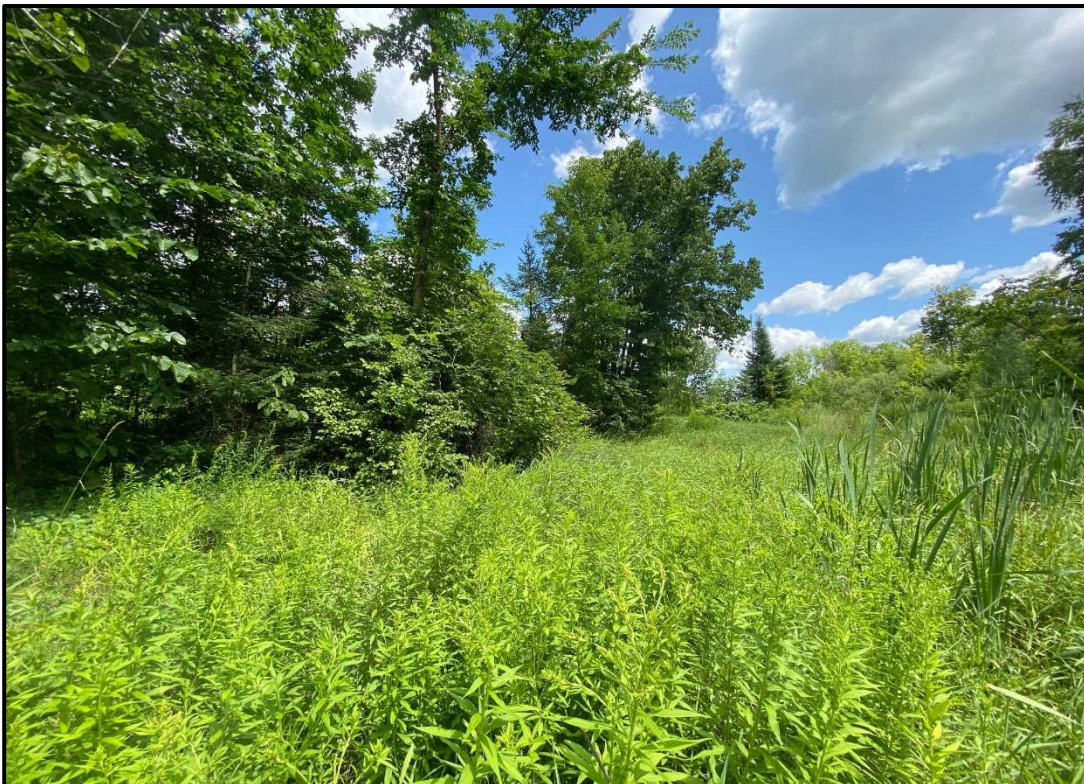
Photo 19B: Photo taken on July 19, 2023 along the watercourse, looking east (upstream).

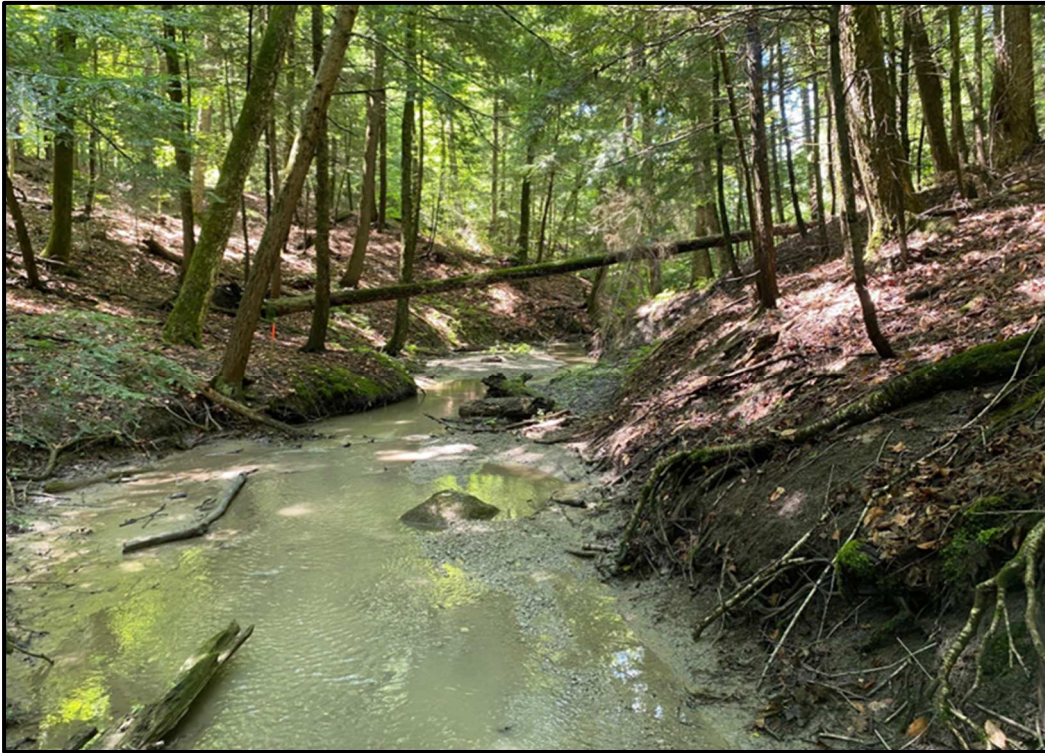
Photo 23: Photo taken on July 19, 2023 of the north slope face, looking west (downstream) near Section H.

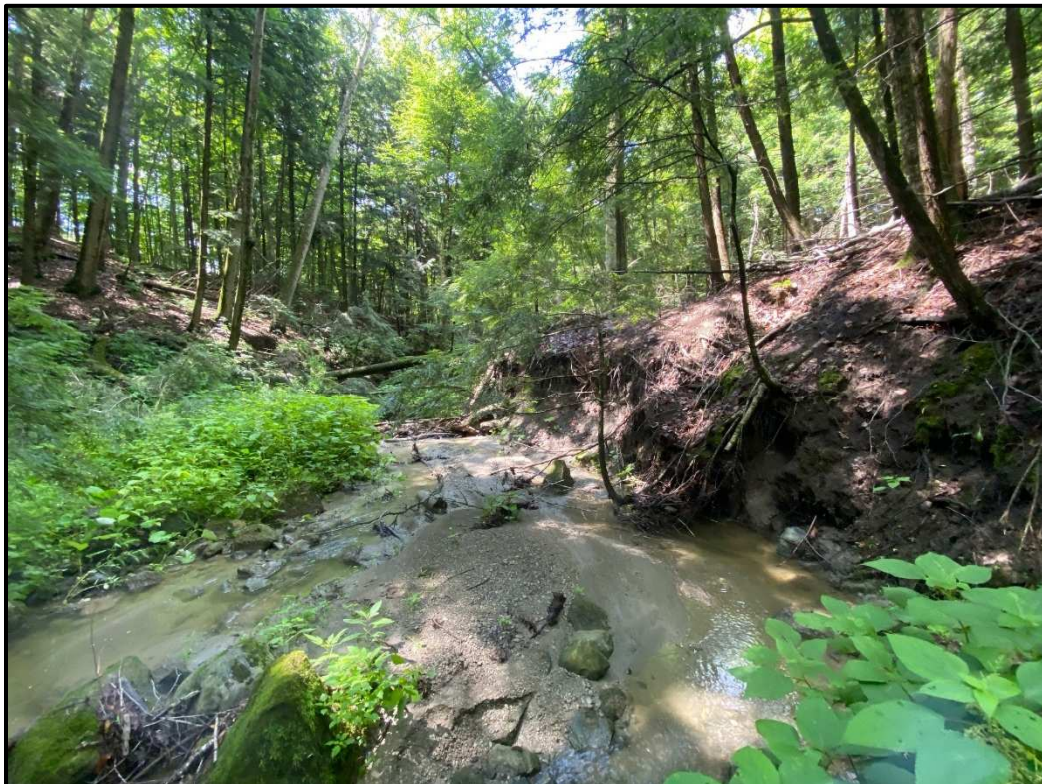
Photo 24: Photo taken on July 19, 2023 of the north slope face, looking west (downstream) near Section CC.

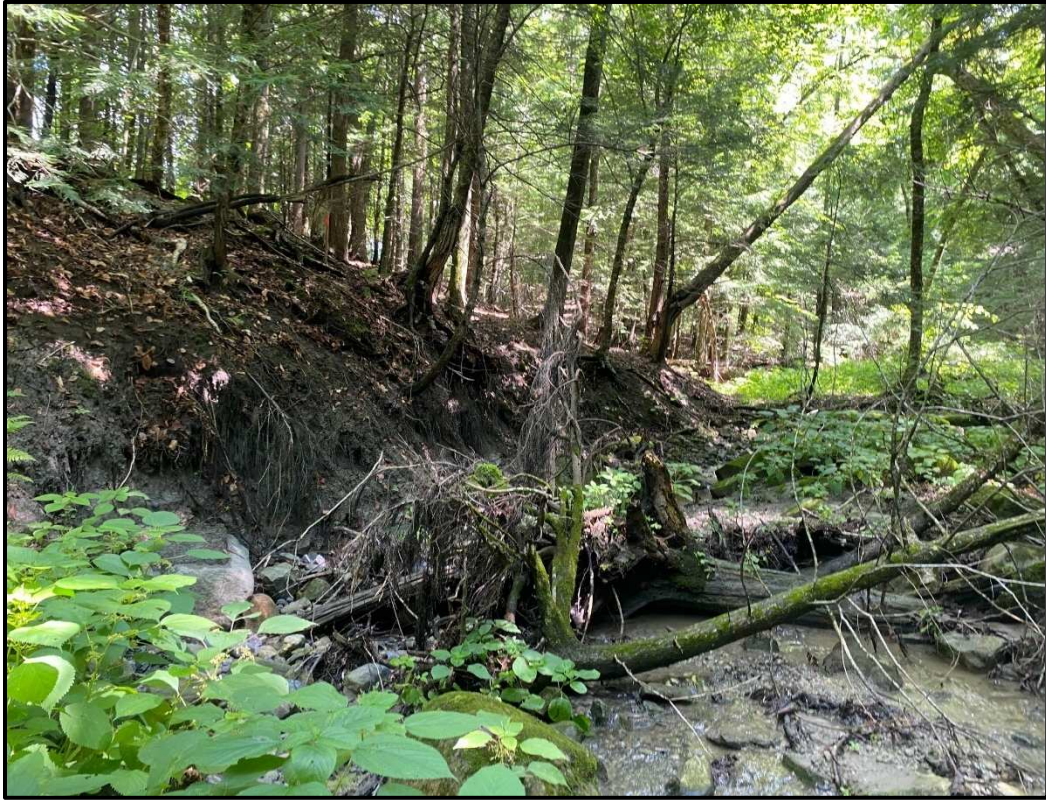
Photo 25: Photo taken on July 19, 2023 of the north slope face, looking east (upstream) near Section CC.
